**FEDERAL ENERGY REGULATORY COMMISSION
ENVIRONMENTAL COMPLIANCE MONITORING PROGRAM
WEEKLY SUMMARY REPORT**

ROVER PIPELINE, PANHANDLE BACKHAUL, AND TRUNKLINE BACKHAUL PROJECTS

DOCKET Nos.: CP15-93-000, CP15-94-000, and CP15-96-000

For the Period: Ending April 7, 2018

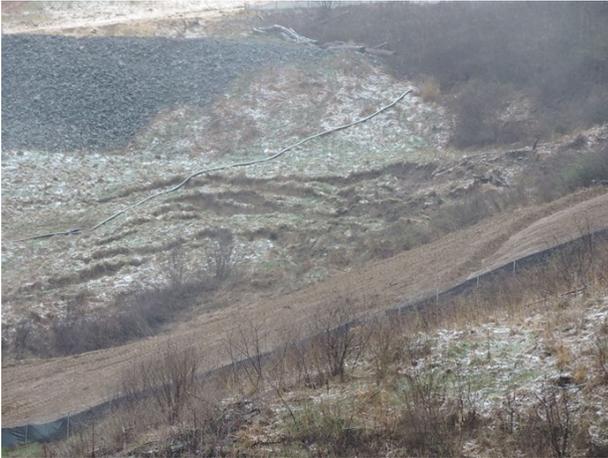
Date	Report #	Start MP	End MP	Construction Method	Report Summary
4/2/2018	CGTLateral_02Apr2018_GH	1.1	4.0	Other (see notes)	<p>A steep slope near station 57+00 was observed. In previous observations, a developing slope failure has been noted. In this inspection, the failure has expanded as a result of the rain event. The failure is encroaching into an adjacent right-of-way, but, at present, is not impacting the small stream at the base of the slope. A second area viewed was the right-of-way on the coming-in side and going-away side of Waldo Run near station 165+12. Rough grading has been completed, but temporary stabilization has not. No issues were found on either slope as a result of the rain event. The final area viewed was the previously noted developing failure on the reroute section of the project near station 209+00. From a distance, the failure did not appear to have expanded, but the potential for additional movement is significant. The failure was present prior to construction, but has noticeably expanded as a result of the pipeline installation. At the conclusion of the inspection, the Compliance Monitor met with the EI to discuss the inspection findings as well as continuing stabilization efforts. Aerial stabilization is to continue, weather permitting, this week.</p>

Existing, expanding failure on reroute section of right-of-way – Communication (CGT Lateral, MP 4.0 – April 2, 2018).

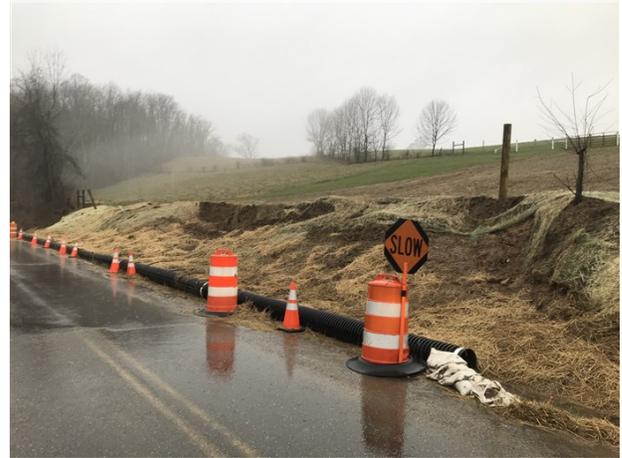
Date	Location	Milepost	Report Summary
4/3/2018	Mainline Spread 1 Pipe B	3.2	The slope failure on the northwest slope above Slab Camp Road (County Road 30) has increased and has not been stabilized. Safety cones and a drain tile have been installed to warn the public and drain runoff along the roadside.
4/4/2018	Burgettstown Lateral	10.9	Sediment migrated down the slope and overwhelmed the sand bag berm that was installed to protect stream S3ES-HA-272. In addition, the erosion control devices (ECDs) have been overwhelmed and buried from the recent slide.

Slope failure above Slab Camp Road – Problem Area (Mainline 1, MP 3.1 – April 3, 2018).

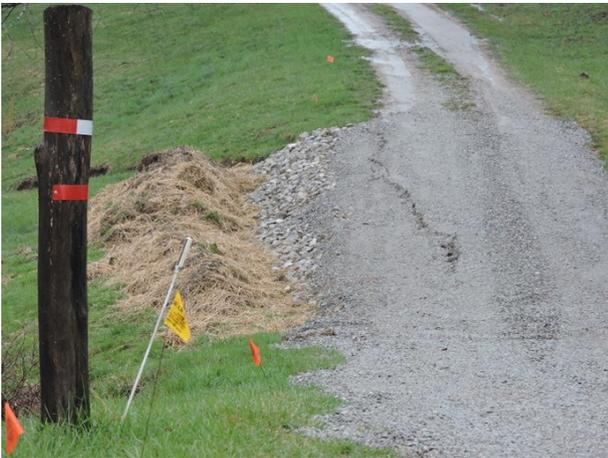
Date	Report #	Start MP	End MP	Construction Method	Report Summary
4/6/2018	SherwoodLateral_06Apr2018_GH	30.5	30.5	Other (see notes)	<p>On April 3, 2018, the Compliance Monitor conducted an inspection on a section of the right-of-way in the vicinity of Starkey Ridge. In that inspection, an off-right-of-way slope failure was found that was beginning to impact the driveway of a private residence. The Lead EI, indicated that the failure was known and was under observation for progressive movement. On April 4, 2018, the Lead EI said that the failure encroaching into the residential driveway had worsened after a significant overnight rain event. After conversations with the Lead EI and consultation with Project Management, it was decided that repairs to the driveway could be undertaken with the acquisition of a Level I variance. On this date, the Compliance Monitor reviewed the submitted variance application, SW-1-20180404, to allow Rover to make repairs to the subject driveway. As per FERC protocol, the variance application was signed by the property owner with the attached map initialed as well. While additional repairs to the failed slope are needed, this variance was only to repair the driveway. The Compliance Monitor approved the variance application on this date.</p>

Damage to driveway from slope failure – Communication (Sherwood, MP 30.6 – April 3, 2018).

FERC Approval Number	Variance Level	Location (Spread)	Location (MP)	Variance Description	Net Acres	Forest Impacts (Acres)	Date FERC Approved	Stipulations / Comments
L1_SW-1-20180404	1	Sherwood Lateral	30.53	Rover requests a variance to add additional temporary workspace that encompasses slip area in order to arrest and repair slip effecting landowner private drive. Area requested is along private drive that is 400 feet by 12 feet extending along the driveway and widens to 20 feet wide in the location of the slip. This will allow access to slip off of Starkey Ridge Road and a wide enough work area at the slip to make repairs. Failed private drive will be stabilized with rock as a temporary measure to allow landowner access to residence.	0.12	0.0	4/6/2018	None

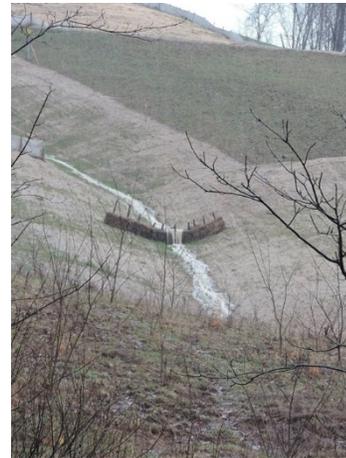
Installed sediment controls being overwhelmed by stormwater runoff – Communication (Sherwood, MP 5.0 – April 3, 2018).

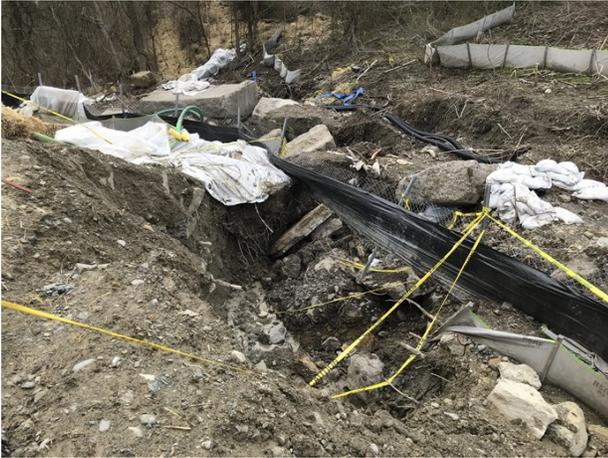
Collapse over trench line – Communication (Majorsville, MP 12.5 – April 5, 2018).

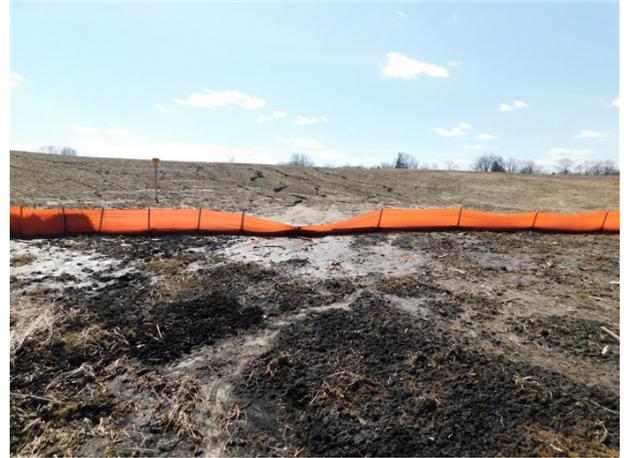
Date	Report #	Start MP	End MP	Construction Method	Report Summary
4/5/2018	MarketSpread 8_05Apr2018_SD	72.3	72.4	ECD Installation	<p>The Compliance Monitor noted that silt fence installed at wetland W2K-WA-192 was filled with sediment and was near failure. A minor amount of filtrate has spilled out past the silt fence for about 10 feet into the wetland boundaries. The filtrate within the wetland is less than 1 centimeter thick. The Compliance Monitor contacted the Lead EI and informed him of the silt fence and that it needed to be repaired as soon as possible. The Lead EI acknowledged the need for repair and informed me that he was already aware of the issue. According to the Lead EI, the environmental inspection and construction inspection staff conducted a post rain event inspection today and recorded the issue; the Lead EI has recorded it as a rain event Problem Area. The Lead EI acknowledged that the repair needs to be made as soon as possible and was coordinating with the environmental crews to make the repairs. The Compliance Monitor will conduct a follow-up inspection to confirm the repairs.</p>

Failing silt fence at the edge of wetland W2K-WA-192 – Communication (Market 8, MP 72.3 – April 5, 2018).

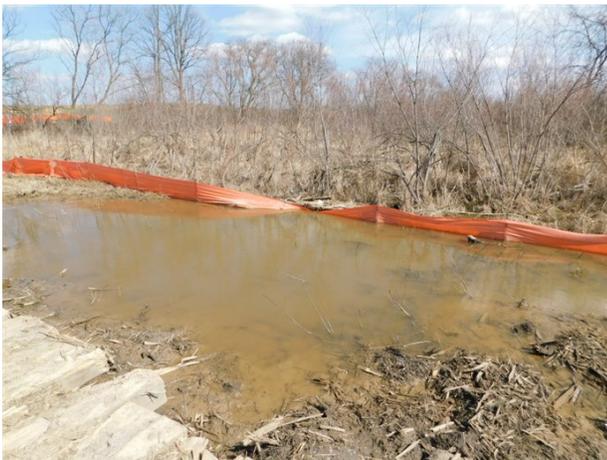
4/6/2018	MarketSpread 8_06Apr2018_SD	74.3	74.3	ECD Installation	<p>The Compliance Monitor noted that silt fence installed at wetland W7K-WA-156 and stream S7K-WA-157 (Fork Mill Creek) was frayed and in need of maintenance. The Compliance Monitor contacted the Lead EI and informed him of the silt fence and that it needed to be repaired as soon as possible. The Lead EI acknowledged the need for repair and informed me that he was already aware of the issue. According to the Lead EI, the environmental inspection and construction inspection staff conducted a post rain event inspection yesterday and recorded the issue. The Lead EI acknowledged that the repair needs to be made as soon as possible and was coordinating with the environmental crews to make the repairs. The Compliance Monitor will conduct a follow-up inspection to confirm the repairs.</p>
4/6/2018	MainlineSpread D Pipe B_06Apr2018_SD	204.6	205.1	Other (see notes)	<p>The Lead EI informed the Compliance Monitor that a channel was dug from the southern portion of tract OH-DE-016 to the bar-ditch of State Highway 24. The Lead EI noted the channel during general right-of-way inspections. The Compliance Monitor will conduct a field inspection to confirm the location of the channel.</p>

Silt fence in need of repair in wetland W7K-WA-156 – Communication (Market 8, MP 74.3 – April 6, 2018).

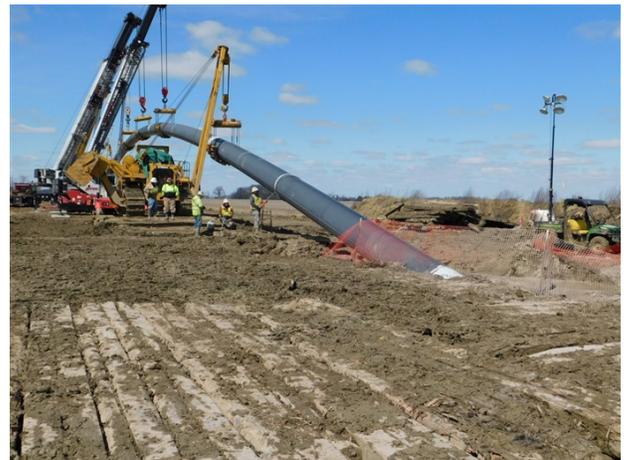
Close-up of State Highway 109 HDD exit point – Acceptable (Mainline D, MP191.1, April 7, 2018).
