**FEDERAL ENERGY REGULATORY COMMISSION
ENVIRONMENTAL COMPLIANCE MONITORING PROGRAM
WEEKLY SUMMARY REPORT**

NEXUS GAS TRANSMISSION PROJECT

DOCKET NO.: CP16-22-000

FOR THE PERIOD: MAY 14 THROUGH MAY 20, 2018

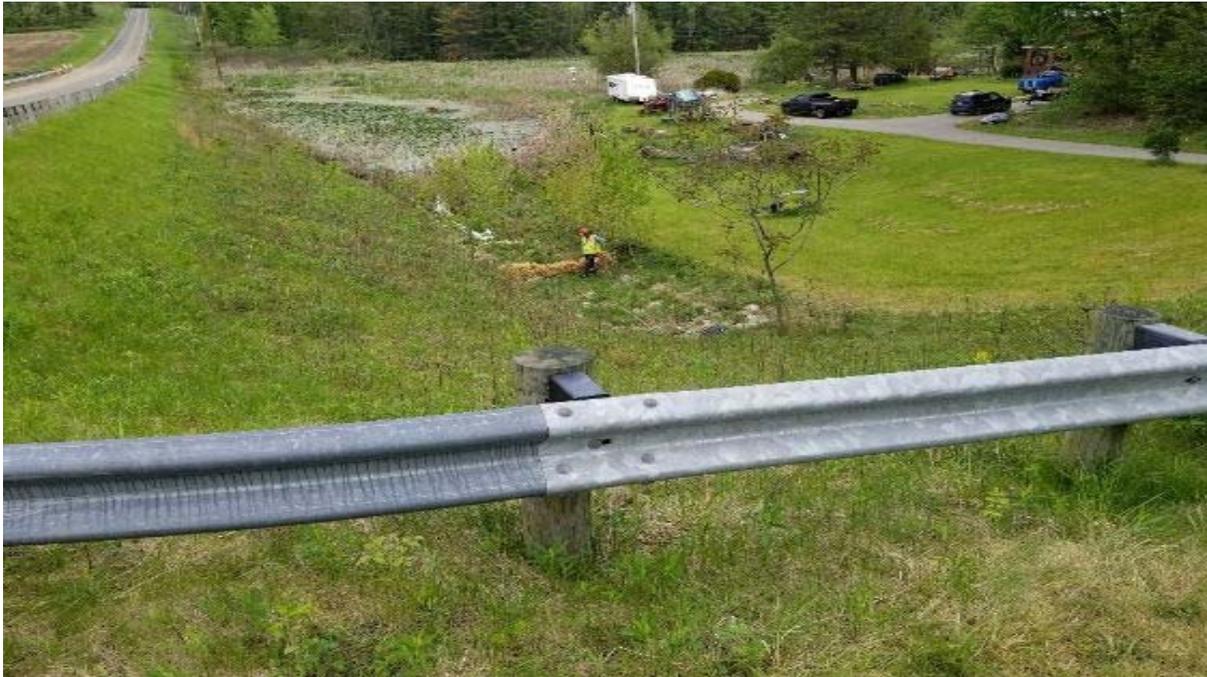
Acceptable Compliance Level, Spread 1, MP 8, View north of the 8-Mile Horizontal Directional Drill (HDD) site.

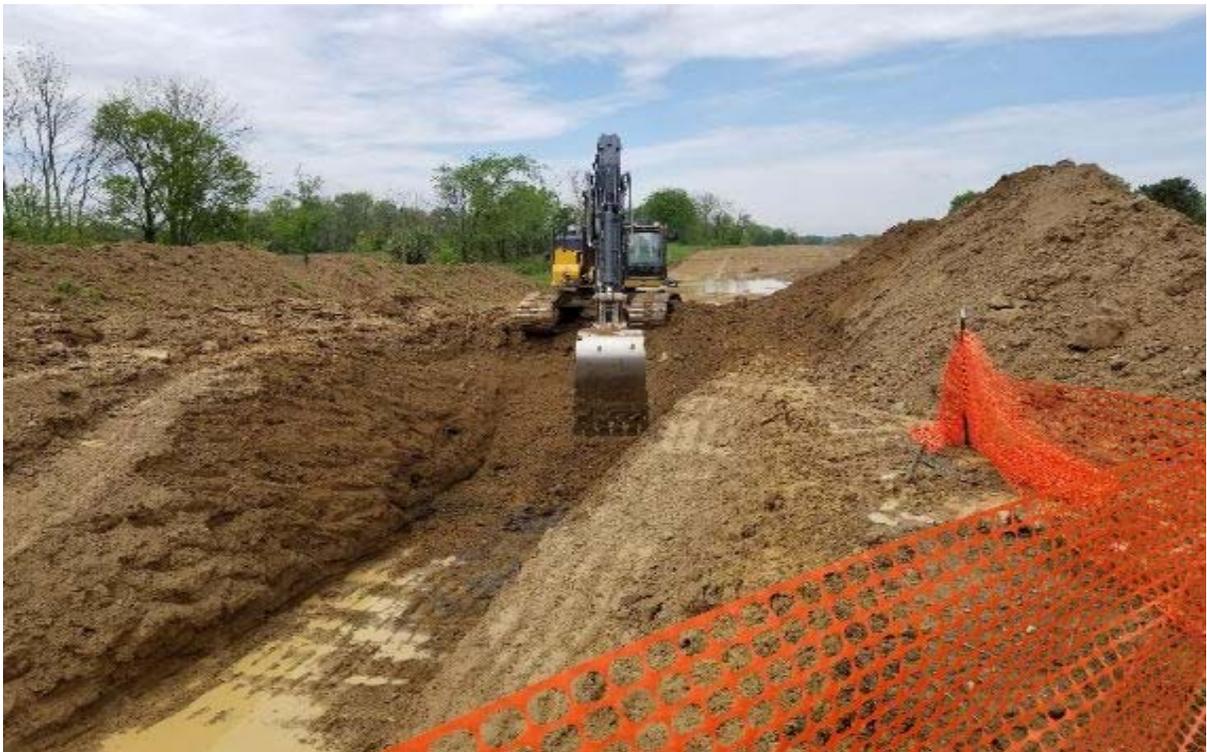
Acceptable Compliance Level, Spread 1, MP 23.5, View west of the bell hole being excavated on the west side of the crossing.

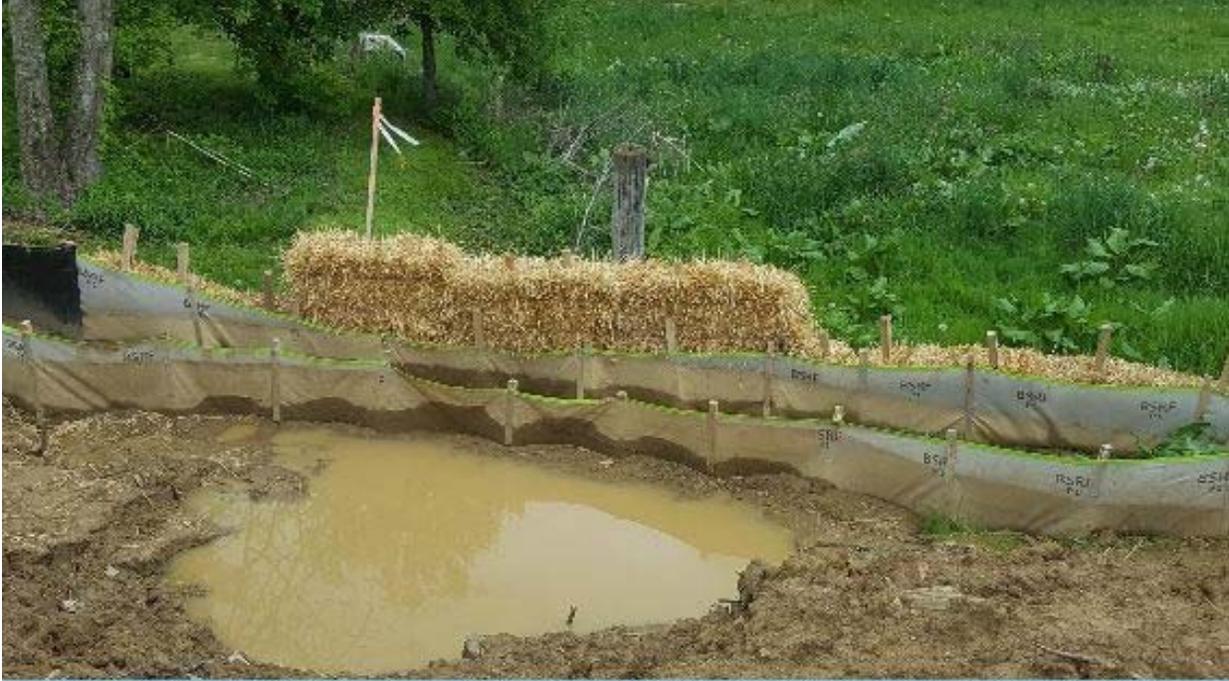
Acceptable Compliance Level, Spread 2, MP 59.5, View north of additional straw bales and another layer of silt fence installed to sediment loss.

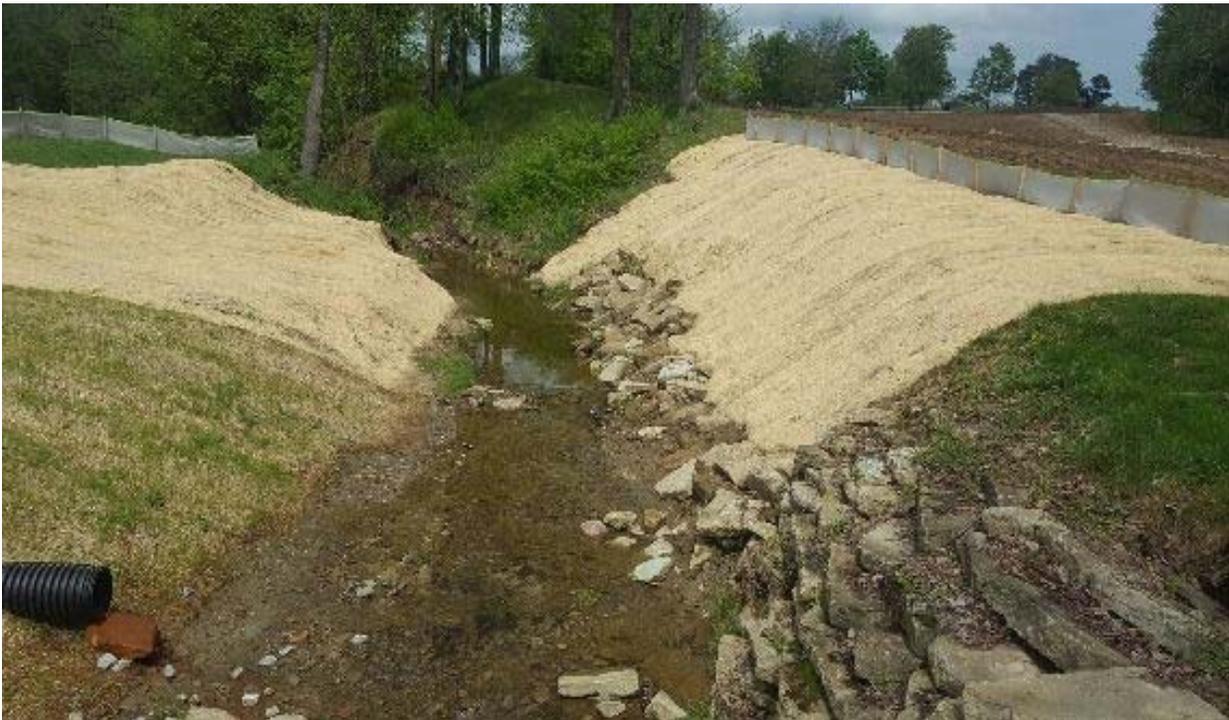
Acceptable Compliance Level, Spread 2, MP 69.1, View east of stream A16-59-S1.

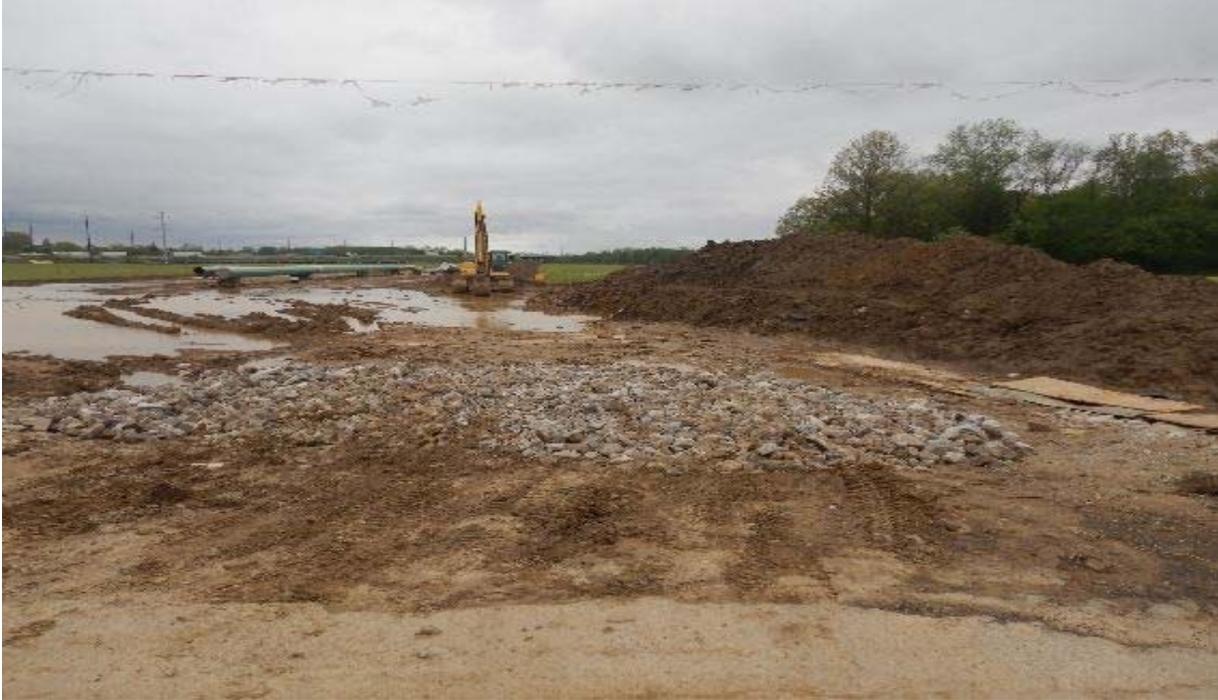
Acceptable Compliance Level, Spread 3, MP 146.1, View west of improved rock construction entrance; limestone was added.

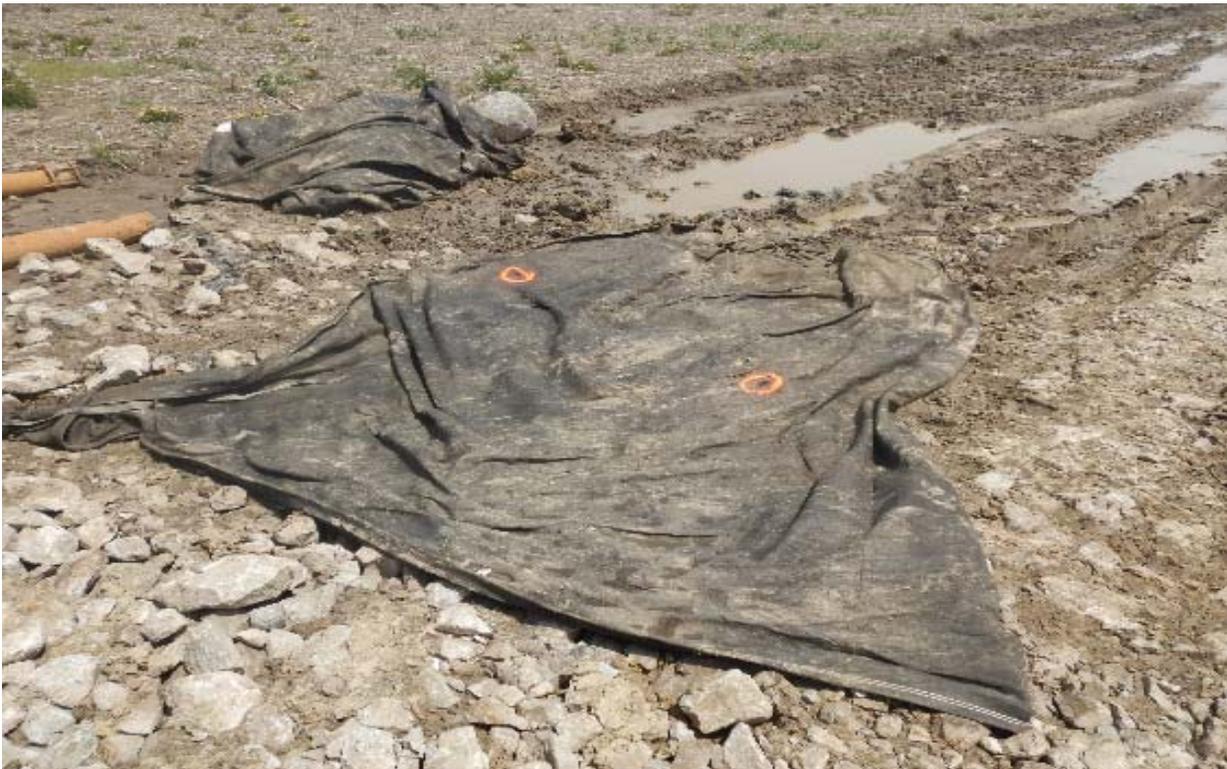
Communication Compliance Level, Spread 3, MP 162.1, View southeast at the observed filter bat with two small punctures noted marked. It could not be determined when these puncture holes occurred and may have resulted from moving the filter bags after dewatering activities.

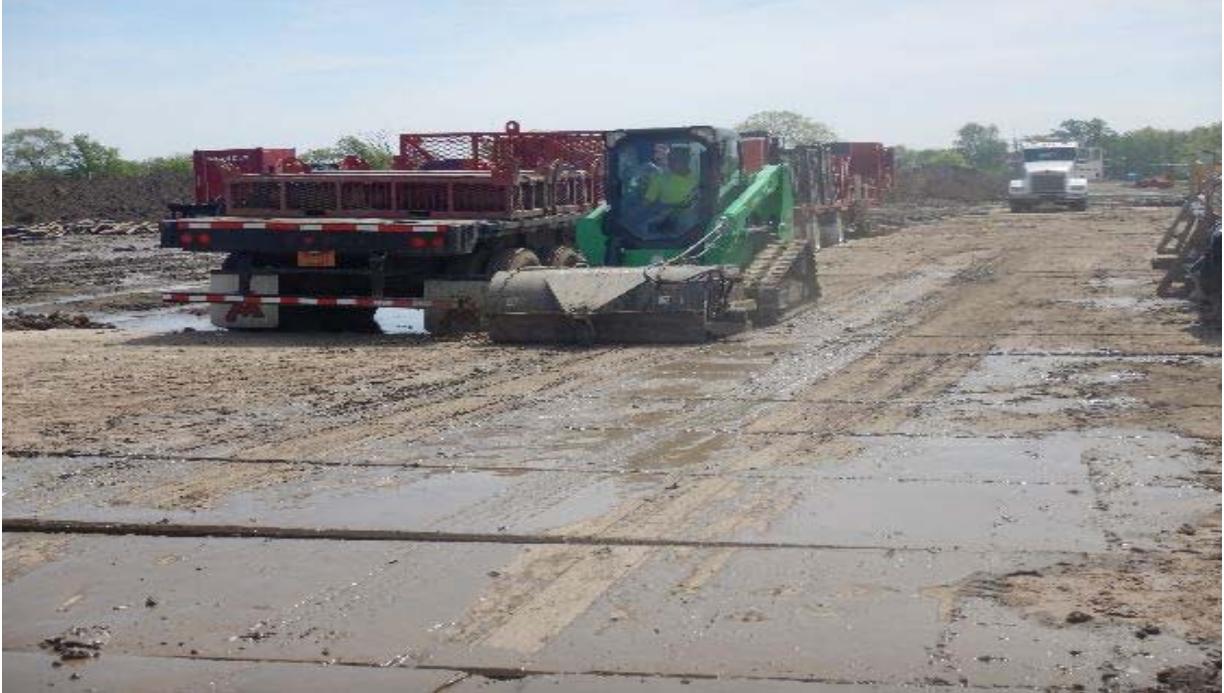
Acceptable Compliance Level, Spread 3, MP 182.2, View southeast of an active rental skid steer with a brush attachment for cleaning construction mats.

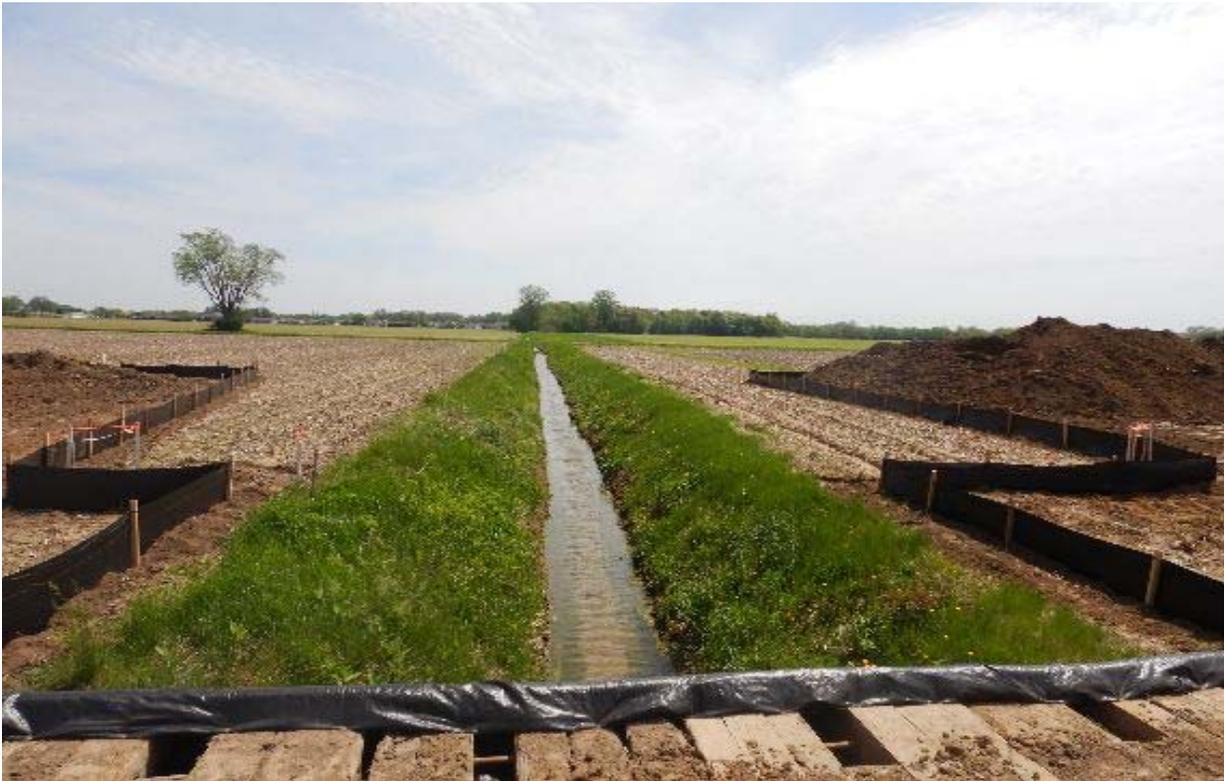
Acceptable Compliance Level, Spread 3, MP 217.3, View east of a bridge over the 15 foot wide Ephemeral Minor Waterbody A16-11-S1 with all sediment barriers in place.
