**FEDERAL ENERGY REGULATORY COMMISSION
ENVIRONMENTAL COMPLIANCE MONITORING PROGRAM
WEEKLY SUMMARY REPORT**

ROVER PIPELINE, PANHANDLE BACKHAUL, AND TRUNKLINE BACKHAUL PROJECTS

DOCKET Nos.: CP15-93-000, CP15-94-000, and CP15-96-000

For the Period: Ending March 24, 2018

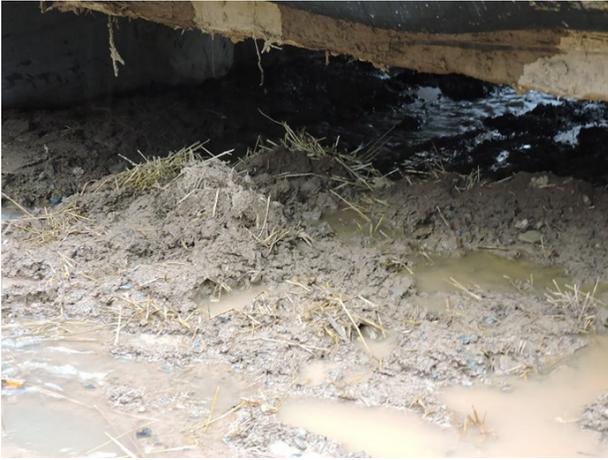
3/20/2018	CGT Lateral	2.8	The bridge at this location was stressed with sediment and stormwater accumulation. There is no current construction traffic across the bridge, but, as long as the bridge is in place, it needs to be maintained.
3/24/2018	Mainline Spread A Pipe B	48.3	There are several areas near the Sugar Creek crossing east of Lawndell Road with erosion and silt fence that is undermined. Sediment migrated off-right-of-way in two locations where it followed the silt fence on the wetland boundary. At the crossing, the undisturbed stream bank on the north side of the right-of-way eroded back into the right-of-way due to a sharp bend in the stream and flooding at this location. The affected area is about a 15 to 18 foot half circle inside of the right-of-way. There was also a piece of steel inside of the hole that needs to be removed and disposed of, as well as some erosion controls in need of repair.

Sediment accumulation in stream channel underneath equipment bridge – Problem Area (CGT Lateral, MP 2.8 – March 20, 2018).

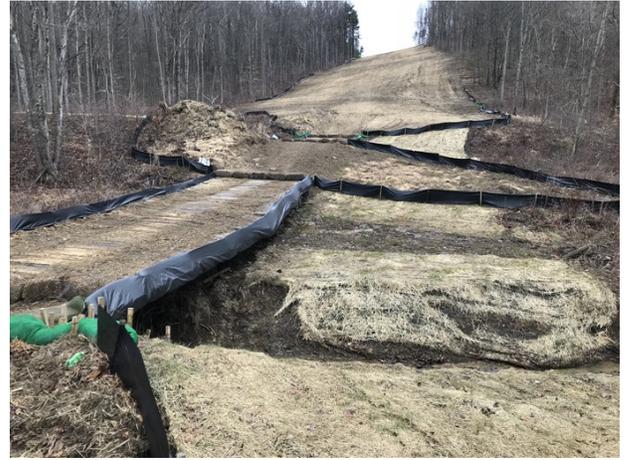
Eastern bank of stream 167 – Problem Area (Burgettstown, MP 46.3 – March 20, 2018).

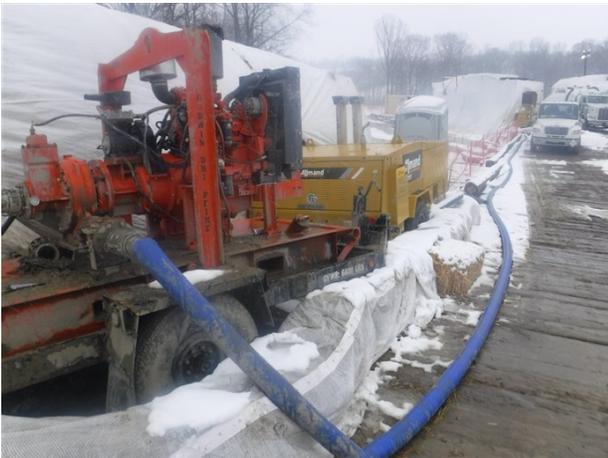
Containments around equipment on the west side of the drill – Acceptable (Mainline A, MP 53.5 – March 21, 2018).

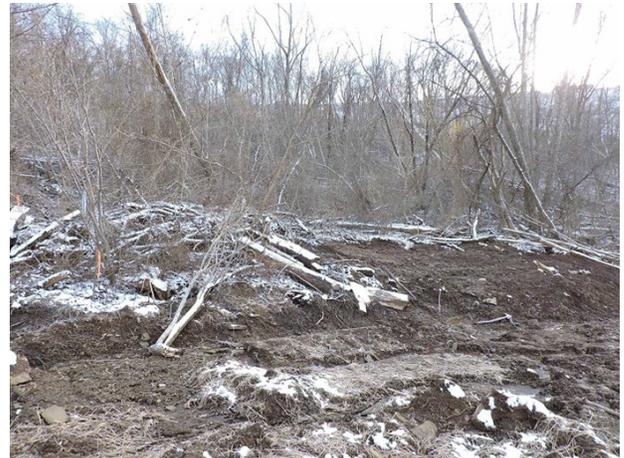
Failed area on upgradient side of right-of-way – Communication (Sherwood, MP 37.9 – March 22, 2018).

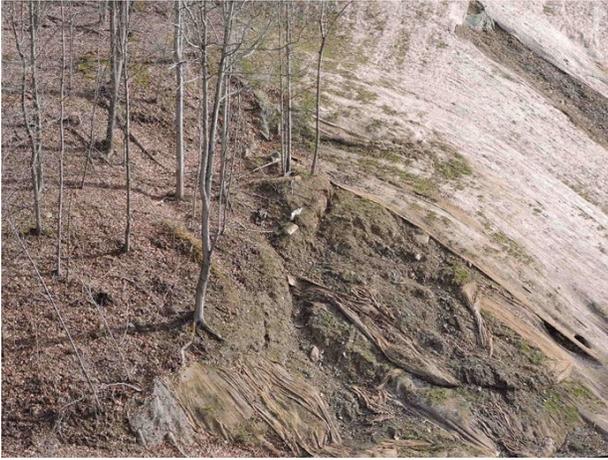
Date	Report #	Start MP	End MP	Construction Method	Report Summary
3/24/2018	SenecaLateral_24Mar2018_GH	22.3	22.5	Other (see notes)	The Compliance Monitor conducted a review of a variance request, SN-1-20180320. The application has been submitted to allow Rover off-right-of-way access to repair slope failures. The impacted areas are not extensive, 146 feet by 41 feet and 379 feet by 82 feet, respectively, and are as described in the application. Access to one of the slide areas will be somewhat problematic in that it is on the side of a steep slope and will require the reinstallation of an equipment bridge to make the mechanical repairs. There are no objections to the request.
3/24/2018	SenecaLateral_24Mar2018_GH	26.1	26.1	Other (see notes)	The Compliance Monitor received a request from the Lead EI to view a developing off-right-of-way slide area in the project area. The request was made to consider the issuance of a Level I variance to allow the contractor to install erosion control structures to contain slide debris before it impacts an ephemeral stream. The slide condition was found to be as described. The Compliance Monitor contacted the Lead EI and advised him that, with landowner approval, the Compliance Monitor would approve foot traffic access to the area to install the requested control structures. The Lead EI advised that he would initiate the application process.

Off-right-of-way slide area to be repaired –
Communication (Seneca, MP 22.3 – March 24, 2018).

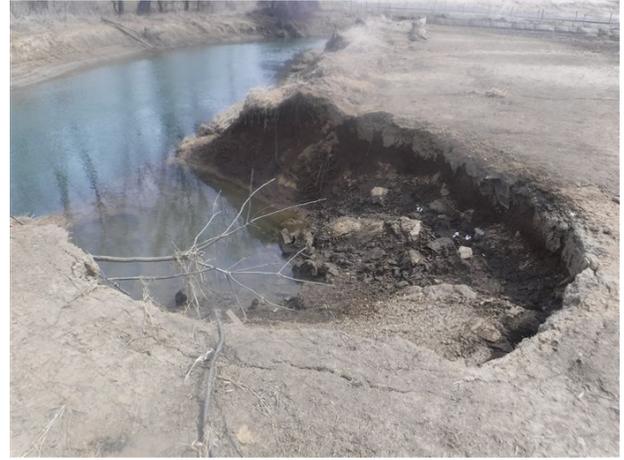
Eroded stream bank from rain and flooded conditions –
Problem Area (Mainline A, MP 47.9 – March 24, 2018).
