**FEDERAL ENERGY REGULATORY COMMISSION
ENVIRONMENTAL COMPLIANCE MONITORING PROGRAM
WEEKLY SUMMARY REPORT**

ROVER PIPELINE, PANHANDLE BACKHAUL, AND TRUNKLINE BACKHAUL PROJECTS

DOCKET Nos.: CP15-93-000, CP15-94-000, and CP15-96-000

For the Period: Ending April 14, 2018

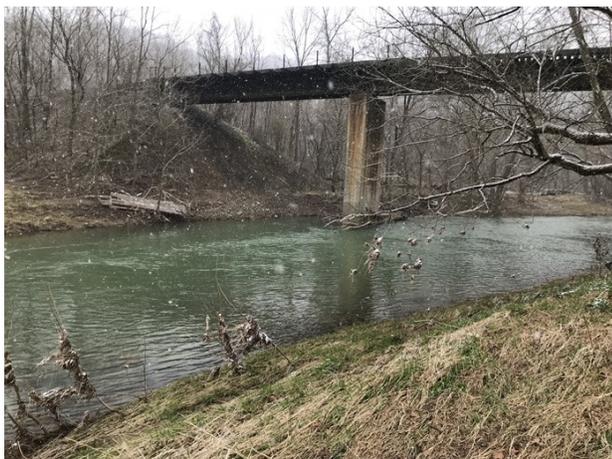
Date	Report #	Start MP	End MP	Construction Method	Report Summary
4/9/2018	ClaringtonLateral_09 Apr2018_BL	5.6	5.6	Cleanup & Restoration	The Compliance Monitor performed a follow-up inspection at station number 295+00 to determine the status of the stranded mats that were washed away from a previous storm event. Three mats remain on the southern bank of Captina Creek (S4H-BE-507). The Compliance Monitor contacted the Lead EI to inquire about the status of the mat retrieval plan. The Lead EI said Rover has been unable to obtain landowner approval to retrieve the mats. The Compliance Monitor informed the Lead EI that the issue has the potential to impact other landowners or bridge crossings downstream. Therefore, Rover needs to resolve the issue with the landowner before it impacts any other landowners.
4/9/2018	ClaringtonLateral_09 Apr2018_BL	3.5	4.3	Cleanup & Restoration	The Compliance Monitor performed a routine inspection between station numbers 185+00 and 226+00 to determine the status of the three slope failures (196+00, 214+00 and 219+00) within the section. A mix of rain and snow left a trace of precipitation on the areas reviewed today. Sediment barriers were in place and functioning along the edge of the limit of disturbance (LOD) and at the resources reviewed. The contractor continues ECD maintenance with foot traffic and hand tools. The site Foreman explained that soil conditions are too wet to allow equipment to work in the area without creating subsequent issues. In addition, he explained that the slope failures are active and continue to move, but they are keeping up with sediment-laden runoff to protect Peavine Creek. The Compliance Monitor contacted the Lead EI to inquire about the status of the failures and when Rover plans to begin repairs. The Lead EI said the failures are still active and explained that Rover's geotechnical specialists have designed schematics for repairs and are currently reviewing them with contractors to make sure that all parties involved understand the issues. The Lead EI said they will be starting repairs soon, but could not give a start date.

Mats stranded on southern bank of Captina Creek – Communication (Clarrington, MP 5.6 –April 9, 2018).

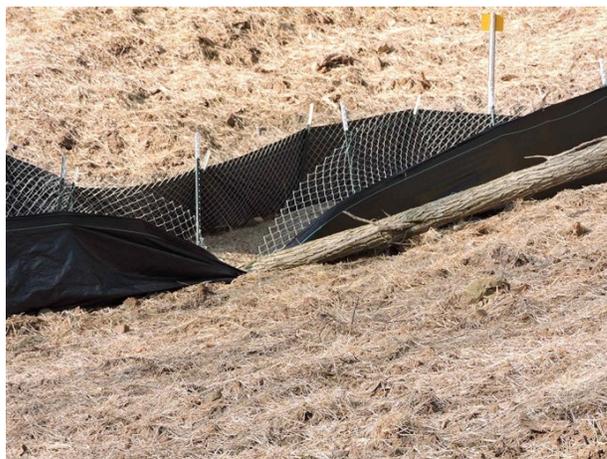
Date	Report #	Start MP	End MP	Construction Method	Report Summary
4/10/2018	CGTLateral_10Apr2018_GH	3.8	4.0	Other (see notes)	<p>The Compliance Monitor conducted a walking tour of the right-of-way to check the status of the efforts for temporary stabilization, installed sediment control structures, and the progression of noted slope failures in the reroute area. The reroute area has been roughly graded, seeded and mulched. Temporary slope breakers have been installed and sediment control structures are in place. There were sections of fencing found that were leaning and needed to be reset. A tree had also fallen across a section of fencing and needs to be repaired. The original failure noted adjacent to the right-of-way near station 209+00 appears to have expanded slightly. The previously noted fractures are more pronounced and the ground surface within the failed area is far more disturbed but it did not appear to have moved further downslope. The most recent failure found on March 26, 2018 is located on the downslope side of the right-of-way near station 207+00. In that previous inspection, it was theorized that the failure is the result of runoff from the right-of-way being directed towards a log pile not associated with the pipeline construction. That added water then saturated and destabilized soils under the timber. The weight of the logs on the saturated soils is what is believed to have triggered the failure. The failure did not appear to have moved downslope any further, but did appear to have expanded horizontally from what was seen in the previous inspection. At the conclusion of the inspection, the Compliance Monitor met with the EI and advised him of the issues found with the sediment control fencing. The EI advised the contractor's environmental personnel of the issues. As for the landslides, variance(s) will be needed to initiate repair of the off-right-of-way failures. It is not known if the variance process has been started.</p>

Tree across fencing, repairs needed – Communication (CGT Lateral, MP 3.9 – April 10, 2018).

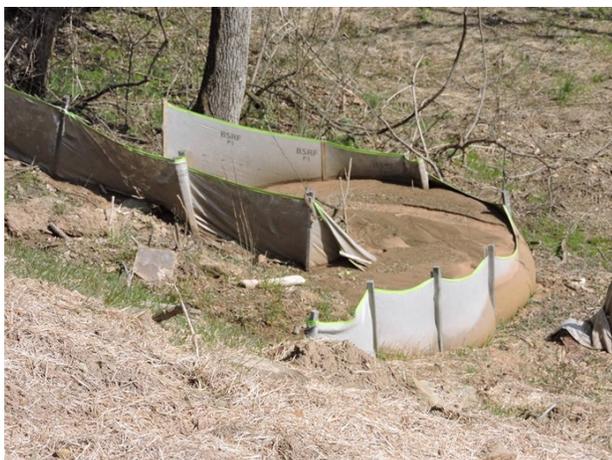
Date	Location	Milepost	Report Summary
4/11/2018	Sherwood Lateral	36.1	Installed sediment barriers at the base of the steep slope above the HDD pad have excessive accumulation of sediment. The right-of-way had been temporarily stabilized with the application of seed and straw mulch, of which most of the straw mulch has been washed away. There is no vegetation and there are deep erosion channels across the right-of-way. Additional areas were observed where the installed controls have excessive accumulations of sediment and other areas where there are no control structures allowing stormwater to leave the right-of-way without first going through any containment measures. At the top of the hill, as with the slope above the HDD pad, no vegetation has been established and significant erosion is occurring across the right-of-way. In conjunction with the erosion issues, deficiencies with installed sediment controls were observed at various locations across this section of the project. A noncompliance is being issue for failure to maintain sediment erosion controls.

Excessive sediment accumulation needs to be removed and stabilized – Noncompliance (Sherwood, MP 36.5 – April 11, 2018).

4/14/2018	SherwoodLateral_14 Apr2018_GH	36.1	36.1	Other (see notes)	<p>The Compliance Monitor conducted a follow-up inspection of a NCR issued on April 11, 2018. In this inspection, a portion of the right-of-way immediately upslope of the HDD pad adjacent to Ohio State Rt. 7 was viewed to determine if corrective actions had been made to deficiencies of installed sediment control structures. Additional controls had been installed on the lower portion of the right-of-way and it appeared that the more heavily impacted controls found in the previous inspection have been replaced. In conversation with the Lead EI, it was reported that the right-of-way was to be seeded and mulched to provide erosion protection until actual restoration efforts can be undertaken.</p>

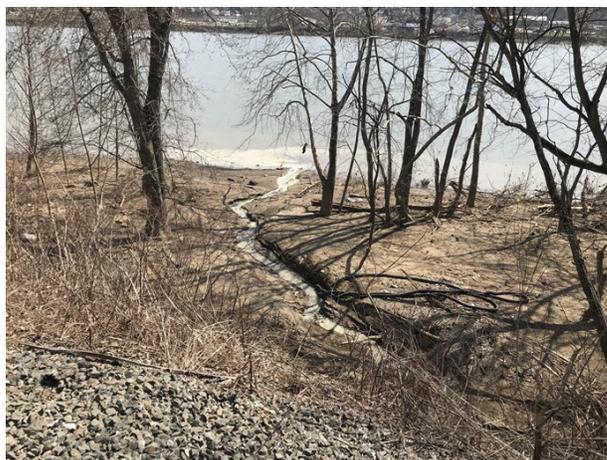
Turbidity entering Ohio River – Communication (Majorsville, MP 12.4 – April 12, 2018).

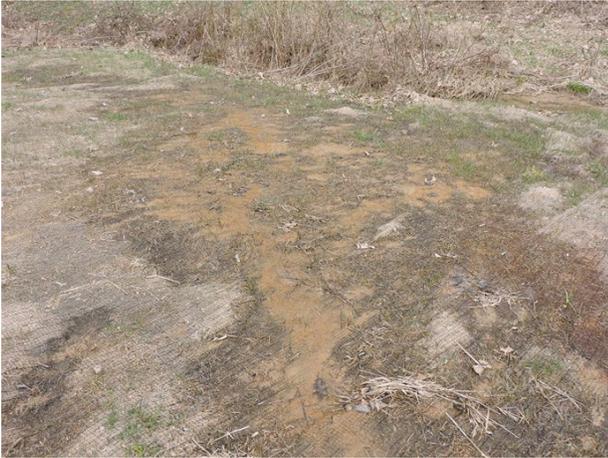
Sediment trail to stream S2TB-MP-202 –
Noncompliance (Sherwood, MP 51.7 – April 12, 2018).

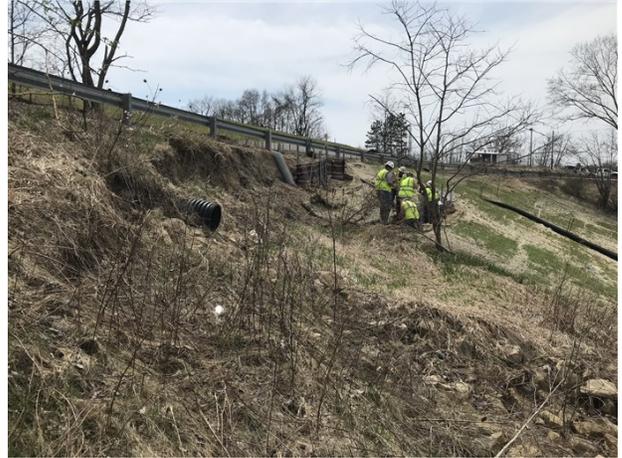
Date	Report #	Start MP	End MP	Construction Method	Report Summary
4/14/2018	ClaringtonLateral_14 Apr2018_BL	2.9	2.9	Cleanup & Restoration	<p>The Compliance Monitor was contacted by the Lead EI about a new slope failure discovered along County Road 5 (Clover Ridge Road). The Lead EI said the contractor wants to install silt fence outside of the LOD to prevent material from the slope failure migrating further away from the right-of-way. Rover considers the situation an emergency request because the failure poses a threat to the collapse of the adjacent road. The Compliance Monitor reminded the Lead EI that a Variance Request with landowner signatures is required for all activity outside of the permitted LOD. The Lead EI said they were working on obtaining landowner approval. Clover Road cuts across a moderately steep slope (10 to 15 percent) on both sides of the road. The failure is on the downslope side near station number 152+50. No indications of a failure were observed on the slope above Clover Road. The Compliance Monitor arrived onsite and observed the contractor installing super silt fence within the right-of-way below the slope failure. The Compliance Monitor reviewed the site with the contractor's foreman and the EI. The EI explained that this section was constructed under the road using bore method. In addition, he added that the area where the failure occurred was above the bore pit and was not disturbed during construction but was blended in during restoration. The failure is 60 feet long with 30 feet extending outside of the LOD. The slope failure leans toward the right-of-way. The site foreman and the EI agreed that future movement would most likely be towards the right-of-way. In addition, both agreed that there was sufficient material along the edge of the road and there is no immediate danger to the road crossing. The EI said they would have their geotechnical specialists review the site today to make sure there is no danger to the public. The Compliance Monitor will follow-up at this location to document stability of the road and slope.</p>

Failed slope area outside the LOD – Communication
(Clarington, MP 2.9 – April 13, 2018).
