**FEDERAL ENERGY REGULATORY COMMISSION
ENVIRONMENTAL COMPLIANCE MONITORING PROGRAM
WEEKLY SUMMARY REPORT**

ROVER PIPELINE, PANHANDLE BACKHAUL, AND TRUNKLINE BACKHAUL PROJECTS

DOCKET Nos.: CP15-93-000, CP15-94-000, and CP15-96-000

For the Period: Ending March 17, 2018

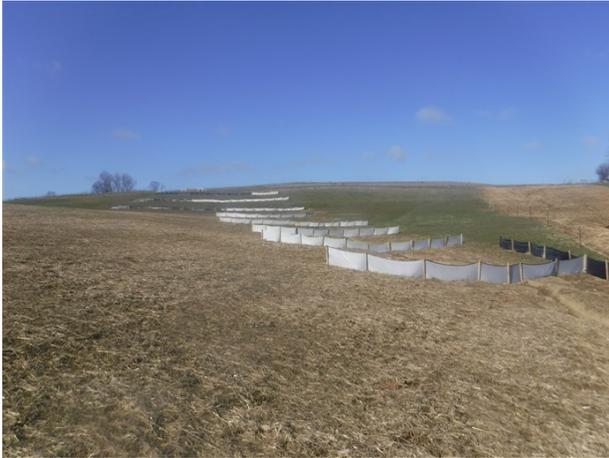
New and repaired sections of silt fence on the right-of-way – Acceptable (Mainline B, MP 54.3 – March 12, 2018).

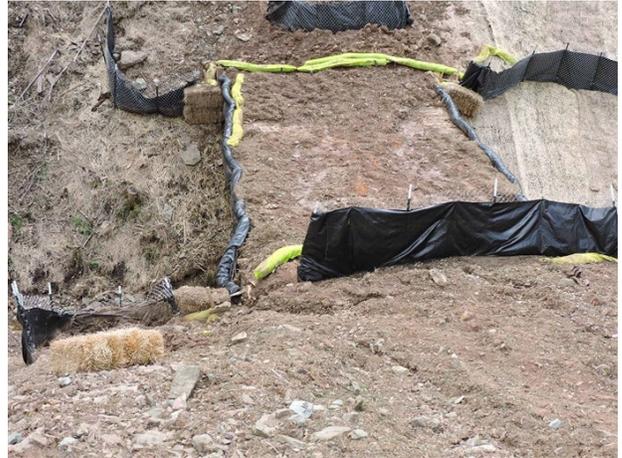
3/13/2018	Sherwood Lateral	22.0	Excessive sediment accumulation was found at several locations where the fencing had been or was near to being overtopped.

Installed equipment bridge at stream S7H-TY-304 with excessive sediment in need of cleaning – Problem Area (Sherwood, MP 22.0 – March 13, 2018).

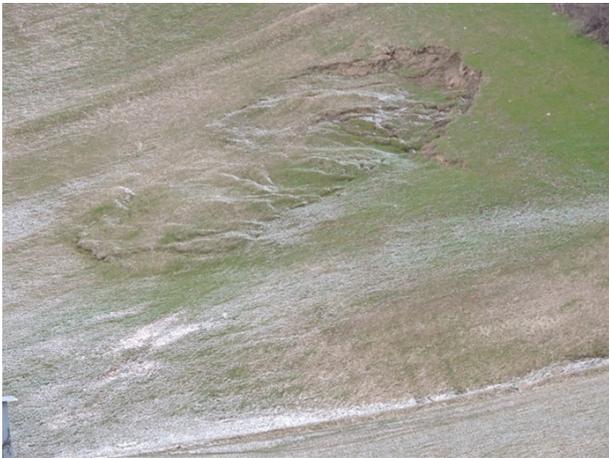
Date	Report #	Start MP	End MP	Construction Method	Report Summary
3/14/2018	SenecaLateral_14Mar2018_GH	9.5	24.6	Cleanup & Restoration	Cleanup and restoration have been completed across the Seneca Lateral and the focus of this inspection was observations of various failures that have developed on the completed right-of-way. All of the observed failures have been documented and are slated for repairs when soil conditions are more suited for mechanical access. Two of the locations are requiring the acquisition of a variance to allow off-right-of-way repairs. Two other locations have failures that are co-located and are not the responsibility of Rover to repair. None of the observed failures have resulted in stream impacts.
3/14/2018	MainlineSpread D Pipe A_14Mar2018_SD	205.1	205.1	Post-construction Restoration	The Compliance Monitor spoke with a landowner regarding his complaint that he filed with the FERC on March 9, 2018. Ultimately, the landowner is dissatisfied with the level of communication that has been expressed by Rover. According to the landowner, a great majority of his complaints and problems could have been resolved prior to filing the letter if Rover had displayed a greater amount of, and quality of, communication with him. The Compliance Monitor explained activities both past and present, and informed the landowner of possible plans, and options of resolution for cleanup of his tracts leading into the future. The landowner replied that if Rover had informed him, and communicated with him in a similar manner, then he most likely would not have written the formal complaint. The Compliance Monitor informed the landowner that should he need further information regarding his properties and work conducted on them, to feel free to contact him; however, any concerns or issues that he may have in the future, he should still continue to file reports, or use the FERC hotline. The Compliance Monitor will continue to conduct follow-up reports on the landowner's properties throughout restoration.

Newly found failure on completed right-of-way – Communication (Seneca, MP 9.5 – March 14, 2018).

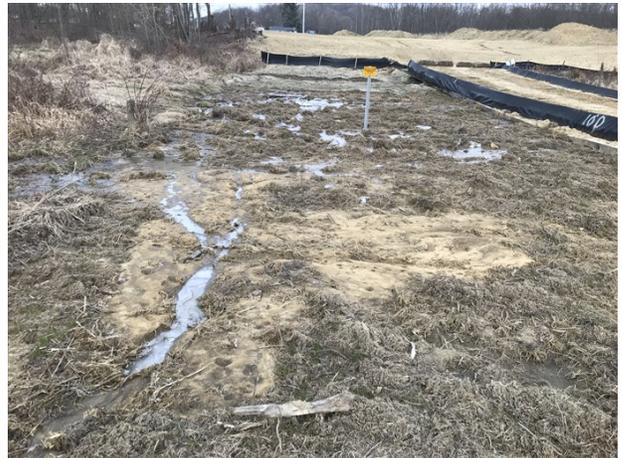
3/15/2018	BurgettstownLateral_15Mar2018_B L	46.9	48.4	Cleanup & Restoration	<p>While performing a post-construction walkthrough, the Compliance Monitor observed that the contractor has improperly installed slope breakers at several locations between Amsterdam Road and Derry Road. The slope breakers were installed at steep angles and in some cases are parallel with the slope. They do not slow runoff down or direct it off the right-of-way into well vegetated areas or use energy dissipation devices. This failure to install/maintain slope breakers has impacted stream S2ES-CA-219 due to the failure at station 2505+00. The Compliance Monitor met with the EI and reviewed photographs of the areas who agreed that the slope breakers were not re-installed at correct angles and actually sped up the runoff. The EI said he would write an Applicant NCR to document the issue and would contact the contractor to make the necessary repairs.</p>

Sediment in wetland W2ES-CA-188 – Communication Applicant NCR (Burgettstown, MP 48.4 – March 15, 2018).

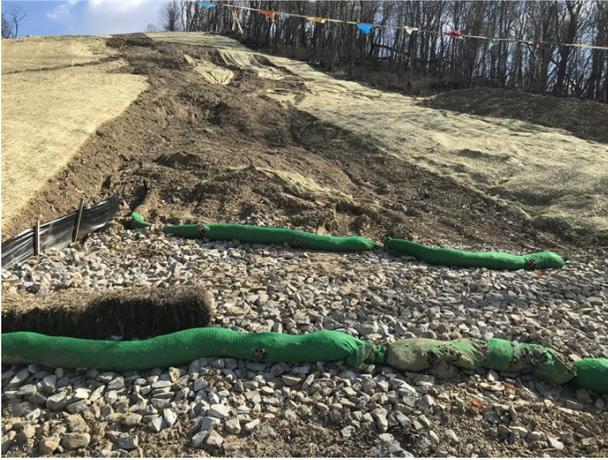
Date	Report #	Start MP	End MP	Construction Method	Report Summary
3/15/2018	BurgettstownLateral_15Mar2018_B L	46.9	50.5	Cleanup & Restoration	<p>The Compliance Monitor continued reviewing the right-of-way for stabilization issues between 2475+62 and 2666+43. Rough grade has been completed throughout this section. In general, this section of the right-of-way is stabilized with the exception of two areas identified at station numbers 2503+18 and 2599+00. At station 2503+18, stream S2ES-CA-217 is a typical riffle and pool system that ranges from 1 to 2 feet wide and about 1 inch deep. A slope failure on the western bank has deposited about 2 to 3 cubic yards of material in the stream and has flowed across the channel and blocked flow. The stream is currently flowing around the blockage. In addition, 2- to 4-inch rock from the culvert bridge crossing washed downstream. The material washed away during the last storm event on February 27, 2018. The affected area is within the right-of-way. No material was observed outside of the LOD. The slope on the northeast side of Deacon Road between station 2598+00 and 2600+00 has washed out. The EI said the area over the trench line subsided and rain events washed material down the slope. The area is within an upland forest. The slope terminates at the edge of Deacon Road. The Compliance Monitor explained that the location has not been stabilized and will need to be addressed as soon as possible. The EI said he would speak to the contractor to find out when the crews will stabilize the area.</p>

Unstable slope above Deacon Road – Communication (Burgettstown, MP 49.2 – March 15, 2018).

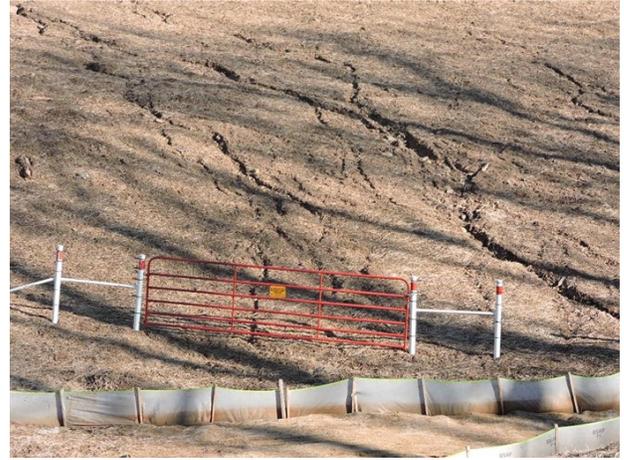
Date	Report #	Start MP	End MP	Construction Method	Report Summary
3/16/2018	SherwoodLateral_16Mar2018_GH	26.8	27.3	Cleanup & Restoration	<p>The Compliance Monitor conducted a walking tour of the right-of-way in the target area. While restoration on some of the observed right-of-way could be considered complete, other sections would need to be considered rough cleanup only and additional work is needed. More significant deficiencies were found in the area of stream S1ES-TY-142. Several areas were found showing accelerated erosion resulting in significant sediment accumulation against installed control structures. No evidence was found of impact to the stream as a result of the sediment accumulation. At the conclusion of the inspection, the Lead EI was contacted and advised of the inspection findings. The Lead EI reported that the deficiencies had been identified and have been included on a punchlist submitted to the contractor to address. Follow-up inspections will be conducted to ensure completion of the needed repairs.</p>

Accelerated erosion above stream S1ES-TY-142 – Communication (Sherwood, MP 27.3 – March 16, 2018).
