**FEDERAL ENERGY REGULATORY COMMISSION
ENVIRONMENTAL COMPLIANCE MONITORING PROGRAM
WEEKLY SUMMARY REPORT**

NEXUS GAS TRANSMISSION PROJECT

DOCKET NO.: CP16-22-000

FOR THE PERIOD: MAY 28 THROUGH JUNE 3, 2018

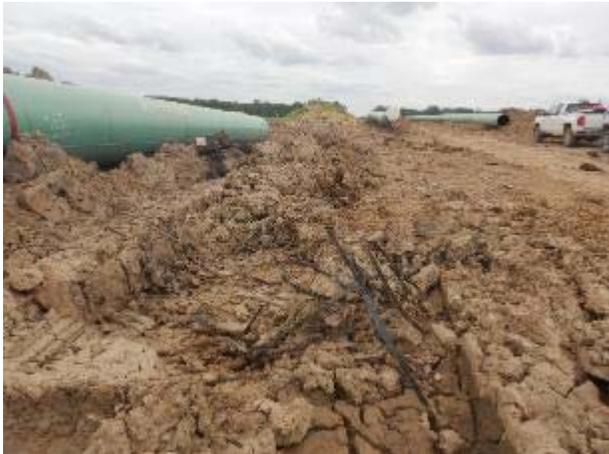
Date	Spread	Location (Milepost)	Follow-up Required (Yes or No)	Problem Area Description
5/30/18	3	154.4 to 154.7	Yes	The CM returned to the area where Compliance Monitor Tina Webb had observed trash and construction debris in various states of disarray on May 23. The CM observed ditching had occurred in the area. Where the CM had informed the Lead EI of the lack of housekeeping on May 23, on May 30 it was observed that debris had mixed with the excavated spoils as the next crew tracked into and conducted the ditching excavations. The CM communicated the observations to the Lead EI. The CM also supplied numerous photos to the Lead EI to provide to the contractor for resolution.

This observed condition was not consistent with section 7.1 of the NEXUS Spill Prevention and Countermeasure Plan which states, "routinely collect and properly dispose of all trash off-site." The CM would follow-up at this location

Spread 3, MP 154.7, View east at steel banding straps in the subgrade requiring removal.

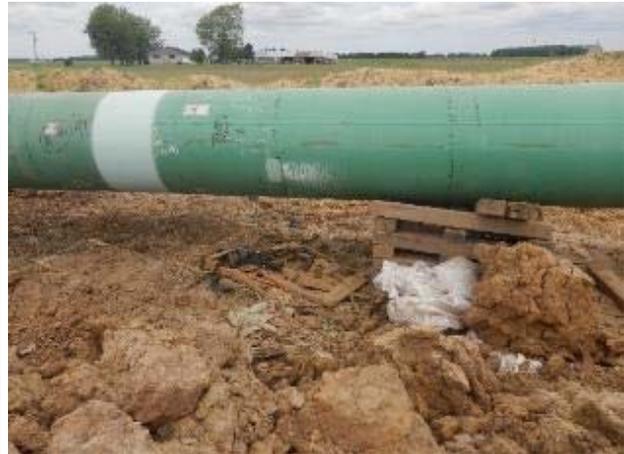
Spread 3, MP 154.7, View north at trash covered by ditch spoil, requiring removal.

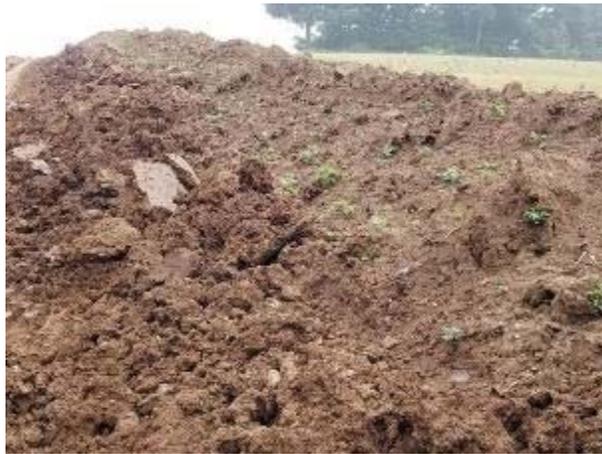
On June 2, the CM observed for approximately 200 feet along the travel lane subsoil piled onto the topsoil pile. The contractor crew was blading the travel lane to remove mud. The CM sent photos to the Lead EI and followed up with a phone call. The Lead EI notified the contractor and was told they will separate the soils the same day.

The topsoil and subsoil mixing was not in compliance with section 3.5.3.1.e of the project's Erosion and Sedimentation Control Plan which states, "maintain separation of salvaged topsoil and subsoil throughout all construction activities."

Soil mixing concerns have been previously noted on February 10, March 16, and May 5 on Spread 1. The CM would follow-up to document resolution of the issue.

Spread 1, MP 8.2, Subsoil piled on topsoil.

The CM was informed that NEXUS would document a problem area report for soil mixing. The Lead EI was also going to retrain the HDD crew on June 4.

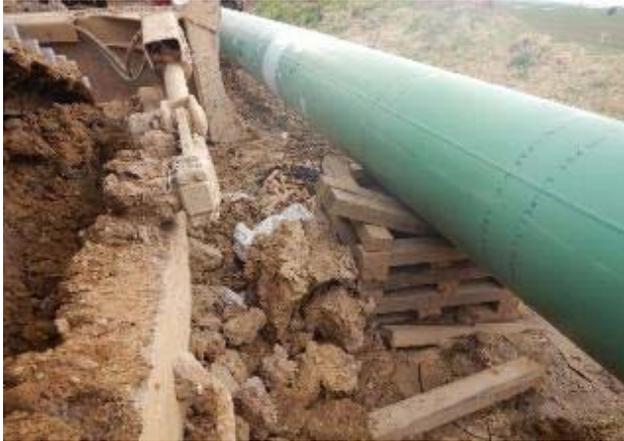
On June 2, the CM returned to the area where trash and construction debris in various states of disarray on May 23. The CM documented a problem area report on May 30 for the observed conditions. The CM observed lowering-in had occurred in the area. Where the CM had informed the Lead EI of the lack of housekeeping on May 23, today it was observed debris had mixed with the excavated spoils as this next crew tracked into and drove over and parked on the trash.

This observed condition was not consistent with section 7.1 of the NEXUS Spill Prevention and Countermeasure Plan which states, "Routinely collect and properly dispose of all trash off-site." The trash in this area needs to be collected and properly disposed of.

Spread 3, MP 154.7, View west at trash documented in earlier report, now parked upon by bulldozer.

The CM contacted the Lead EI and described some of the observations of this trash driven upon by lowering-in activities. The Lead EI stated that trash was being collected prior to backfill. The CM told the Lead EI that backfilling machinery was parked upon the tract. The Lead EI called the CM back and told the CM, the contractor superintendent was notified of the excess trash for collection.

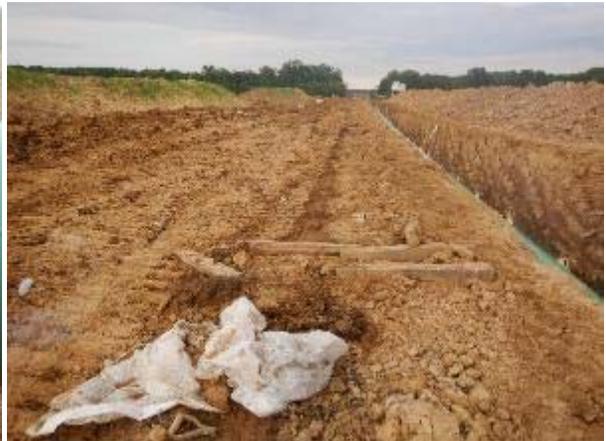
Spread 3, MP 154.6, View east at ropes, coating debris, construction debris, water bottles and trash after lowering-in requiring removal.

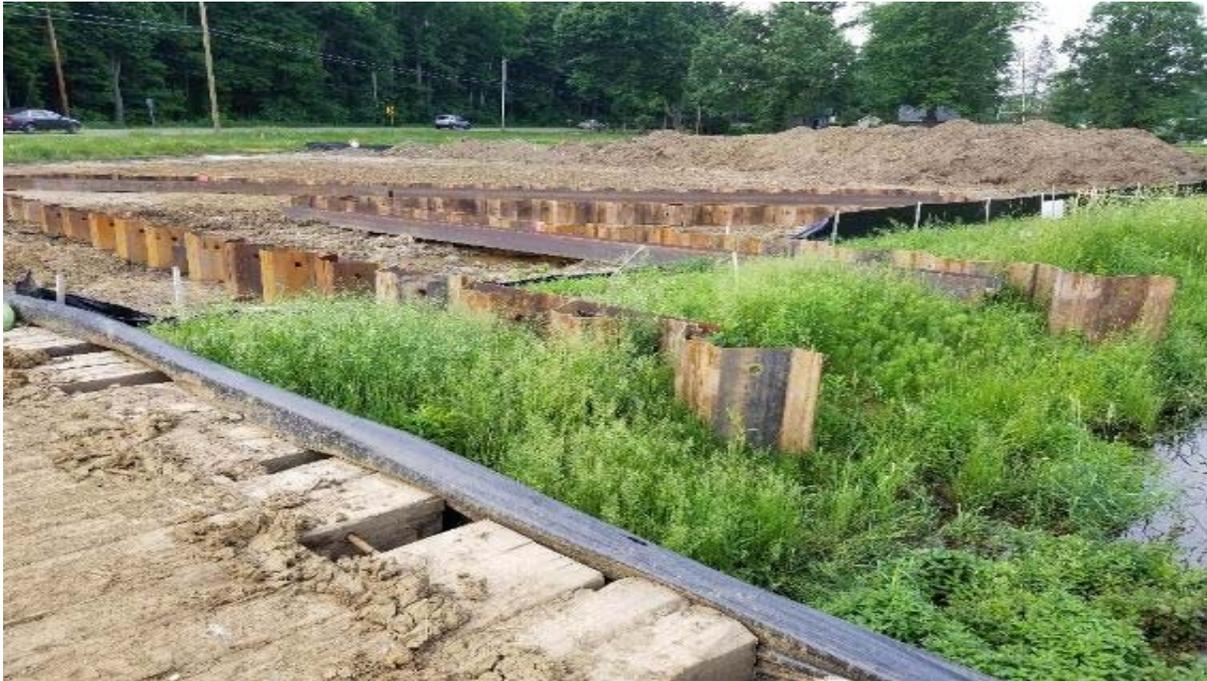
Acceptable Compliance Level, Spread 1, MP 29.1, View southeast of sheet piling installation complete at waterbody B15-101-S1.

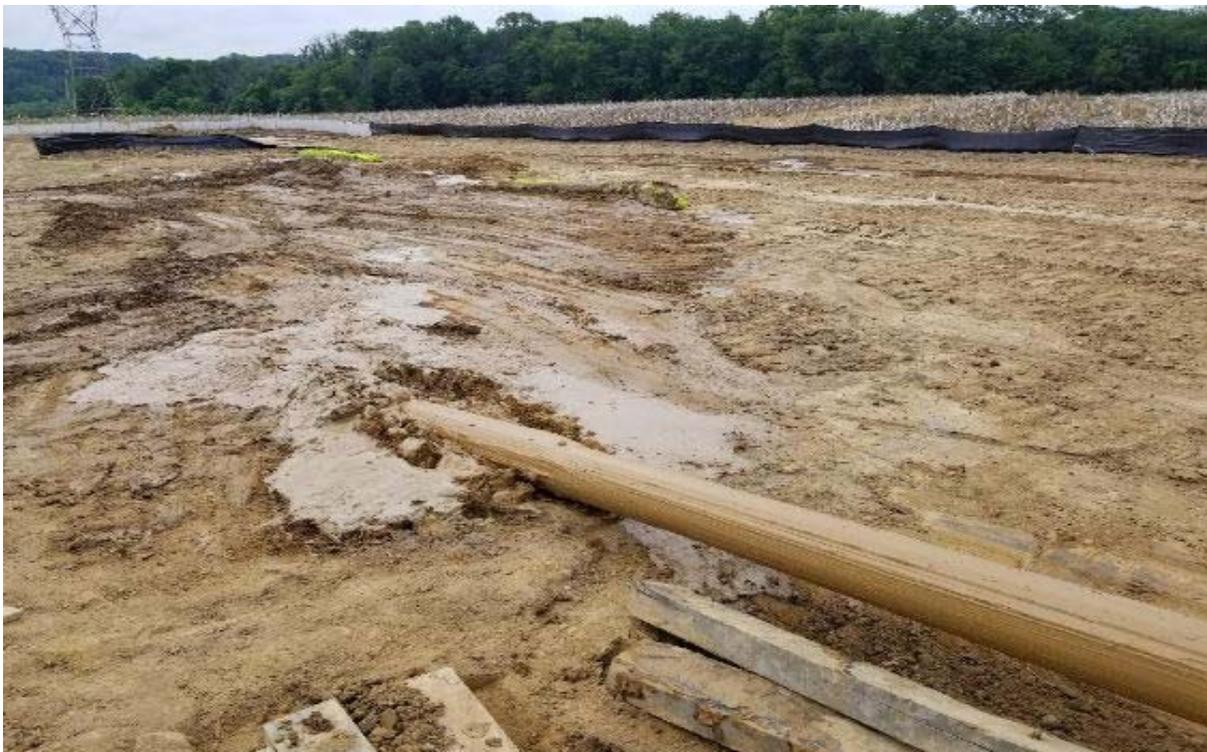
Acceptable Compliance Level, Spread 1, MP 48.5, View southeast of the Tuscarawas River HDD exit site.

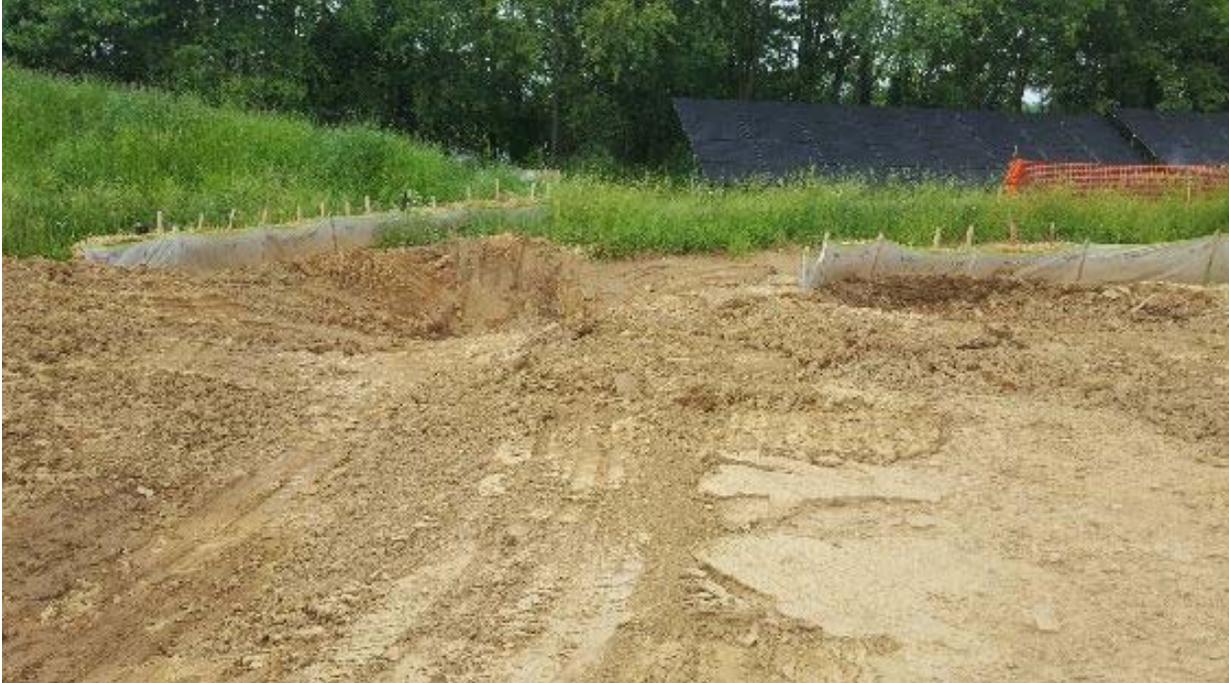
Acceptable Compliance Level, Spread 2, MP 54.5, View north of a water breaker diverting run-off into a sump hole. ECDs are in place for any excessive run-off.

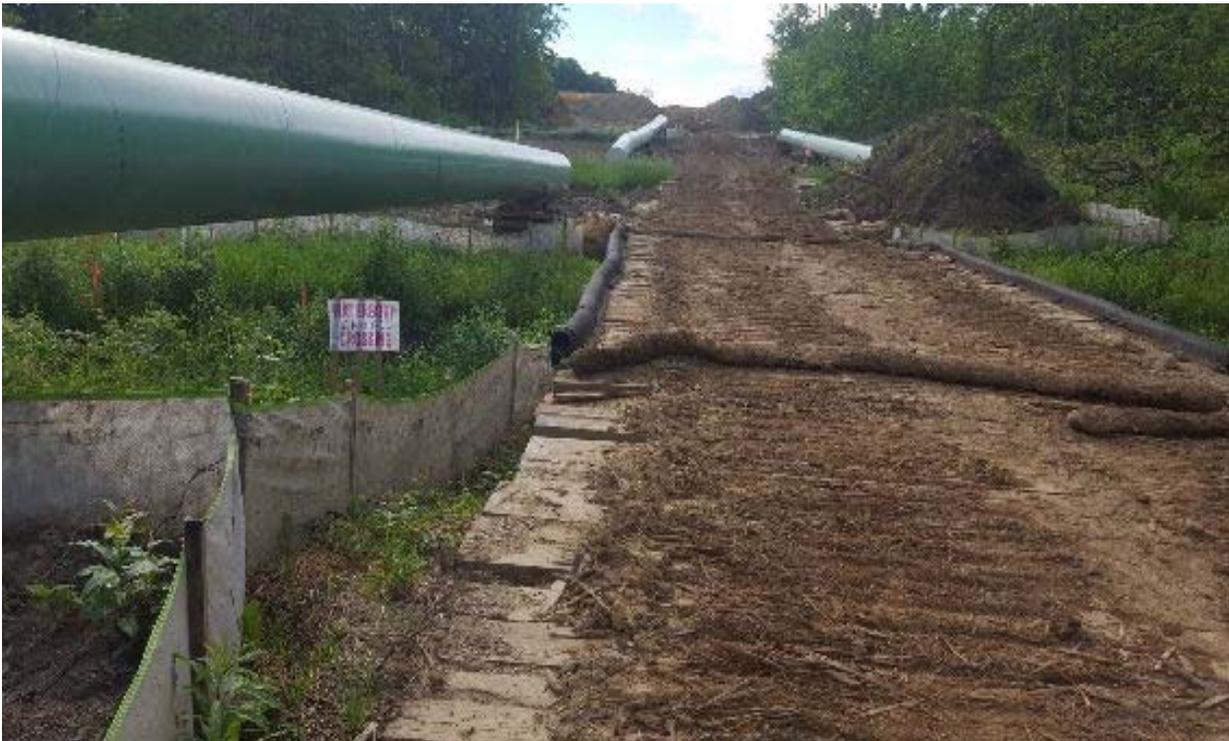
Acceptable Compliance Level, Spread 2, MP 65.5, View north of stream A14-116-S2.

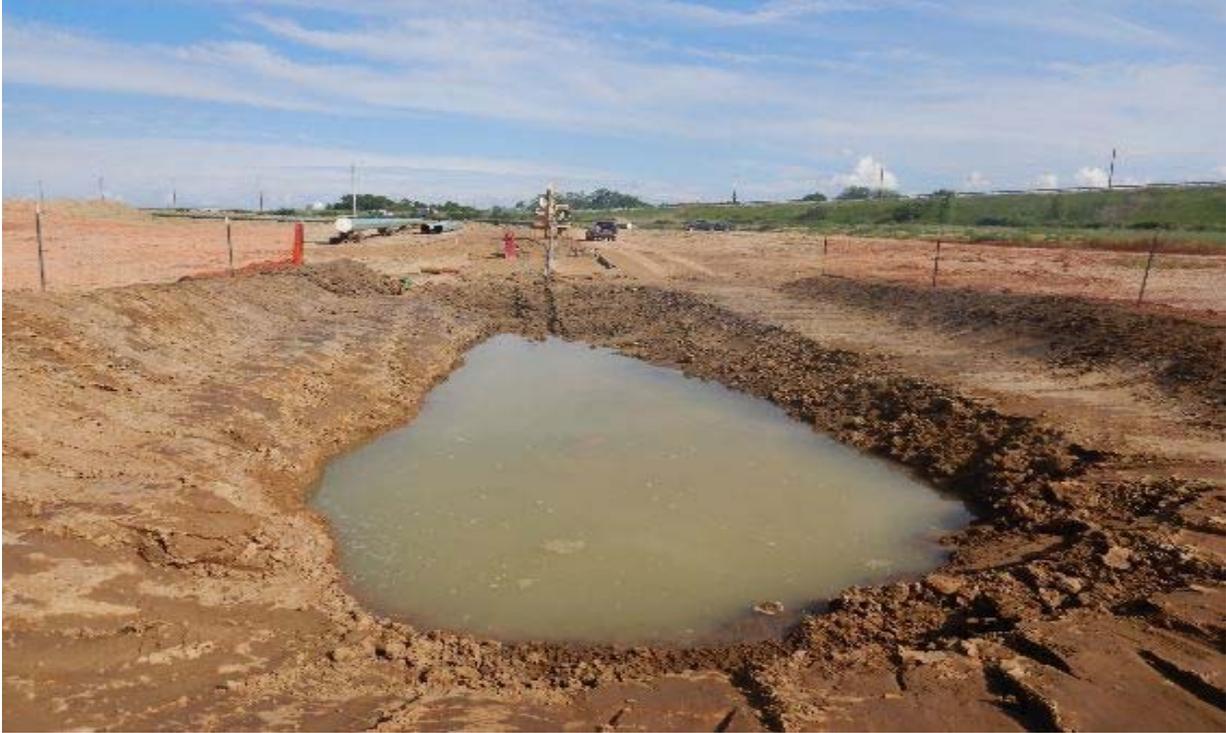
Acceptable Compliance Level, Spread 3, MP 146.6, View southeast of the Sandusky HDD exit tail string during 36-inch-diameter reaming.

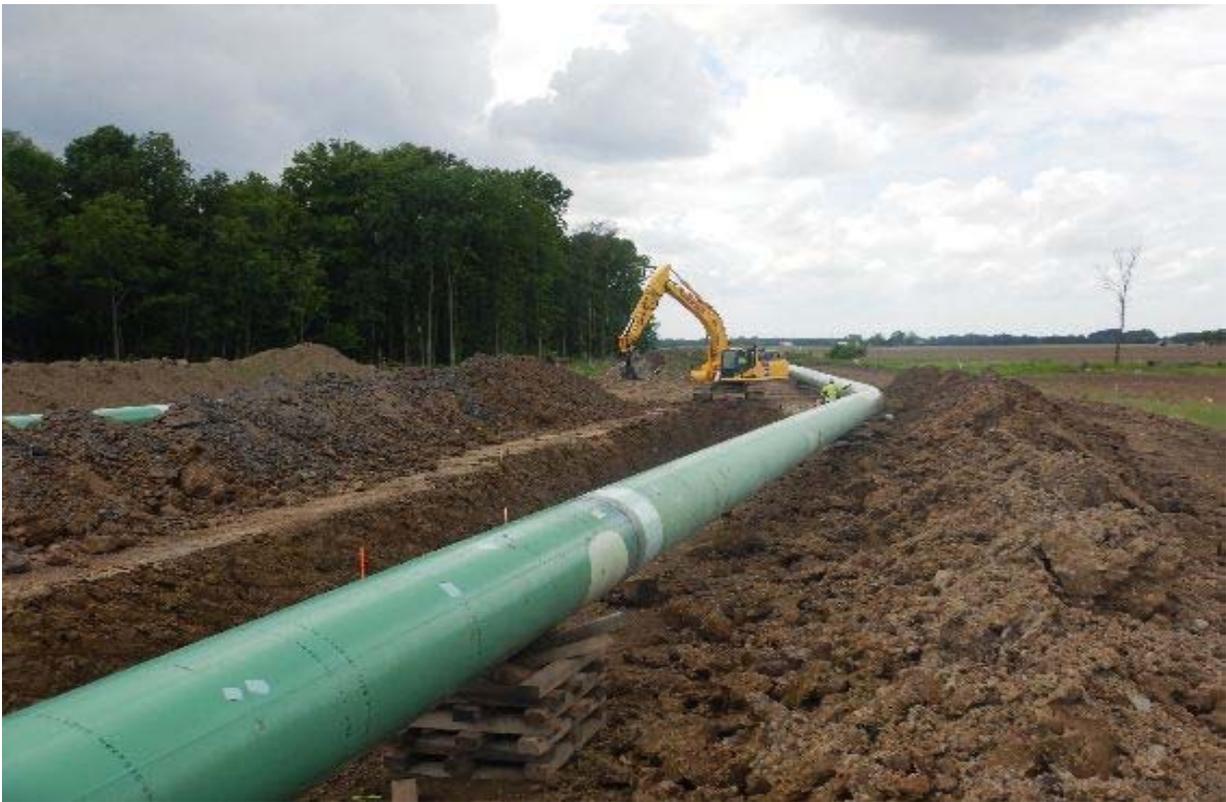
Acceptable Compliance Level, Spread 3, MP 161.6, View west of ditching triple lift area.

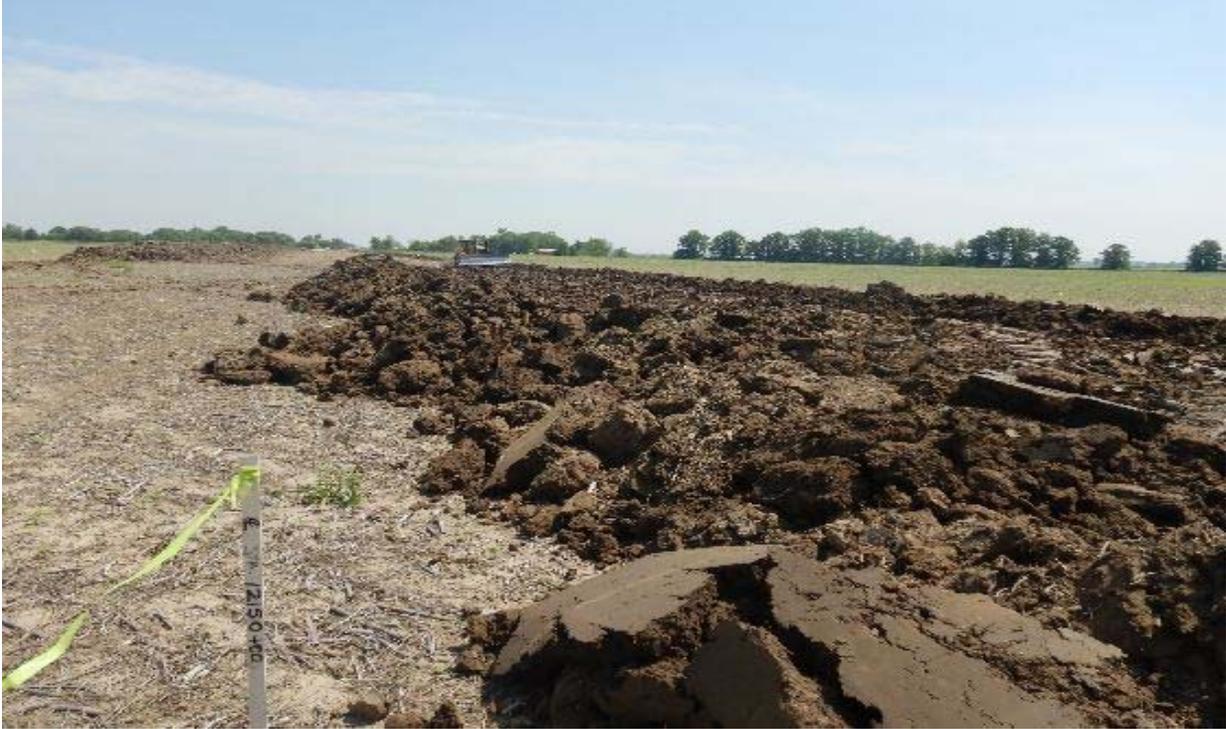
Acceptable Compliance Level, Spread 4, MP 230.1, View north of topsoil grading.

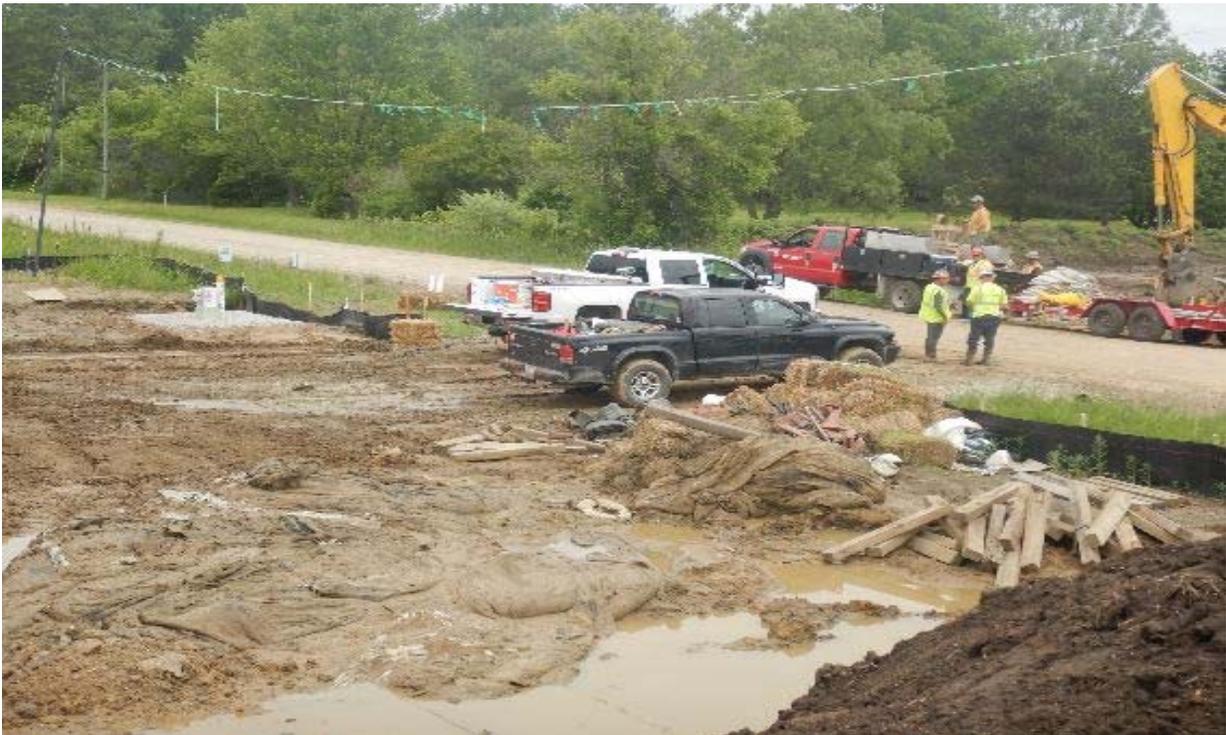
Acceptable Compliance Level, Spread 4, MP 247.6, View northeast of a filter bag returned to the workspace by the cathodic protection crew.
