**FEDERAL ENERGY REGULATORY COMMISSION  
 ENVIRONMENTAL COMPLIANCE MONITORING PROGRAM  
 WEEKLY SUMMARY REPORT**

**NEXUS GAS TRANSMISSION PROJECT**

DOCKET NO.: CP16-22-000

FOR THE PERIOD: MAY 7 THROUGH MAY 13, 2018

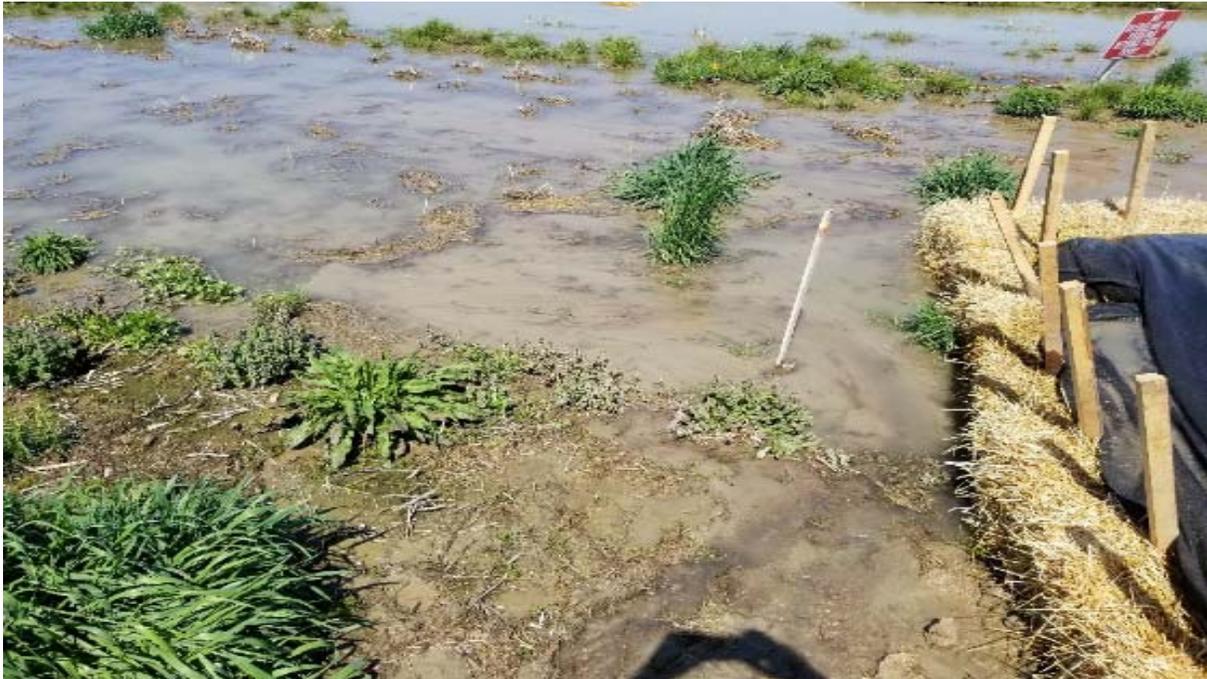
Communication Compliance Level, Spread 1, MP 2.1, View northwest of a small volume of sediment beginning to form due to dewatering discharge in upland area.

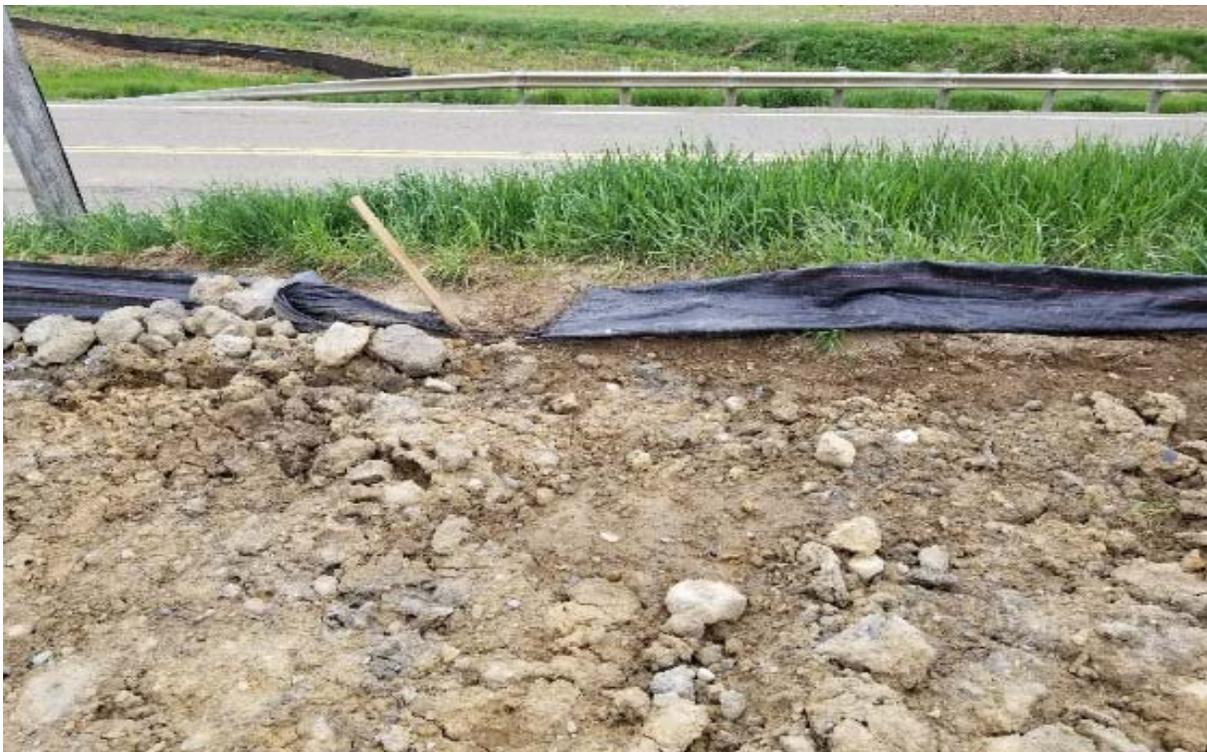
Communication Compliance Level, Spread 1, MP 12.46, View south at damaged silt fence. The EI was contacted for repair. No offsite sediment deposition was observed.

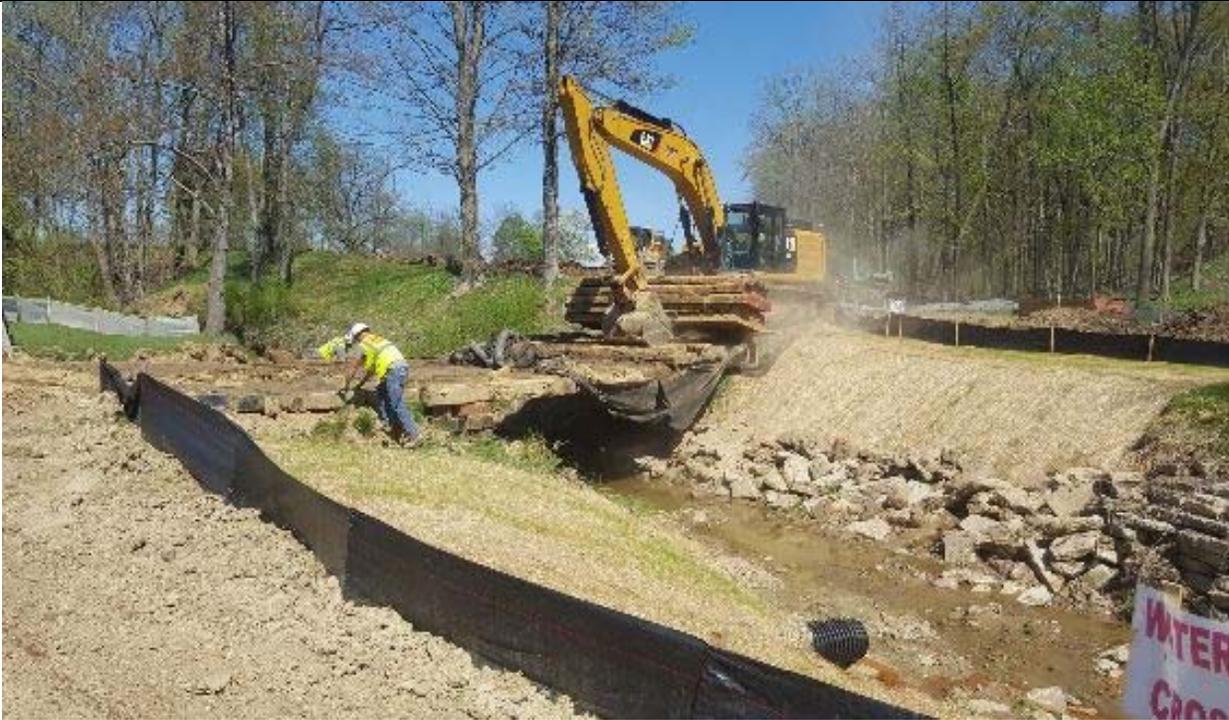
Acceptable Compliance Level, Spread 2, MP 69.7, View southeast of a bridge at stream A16-59-S1 removal.

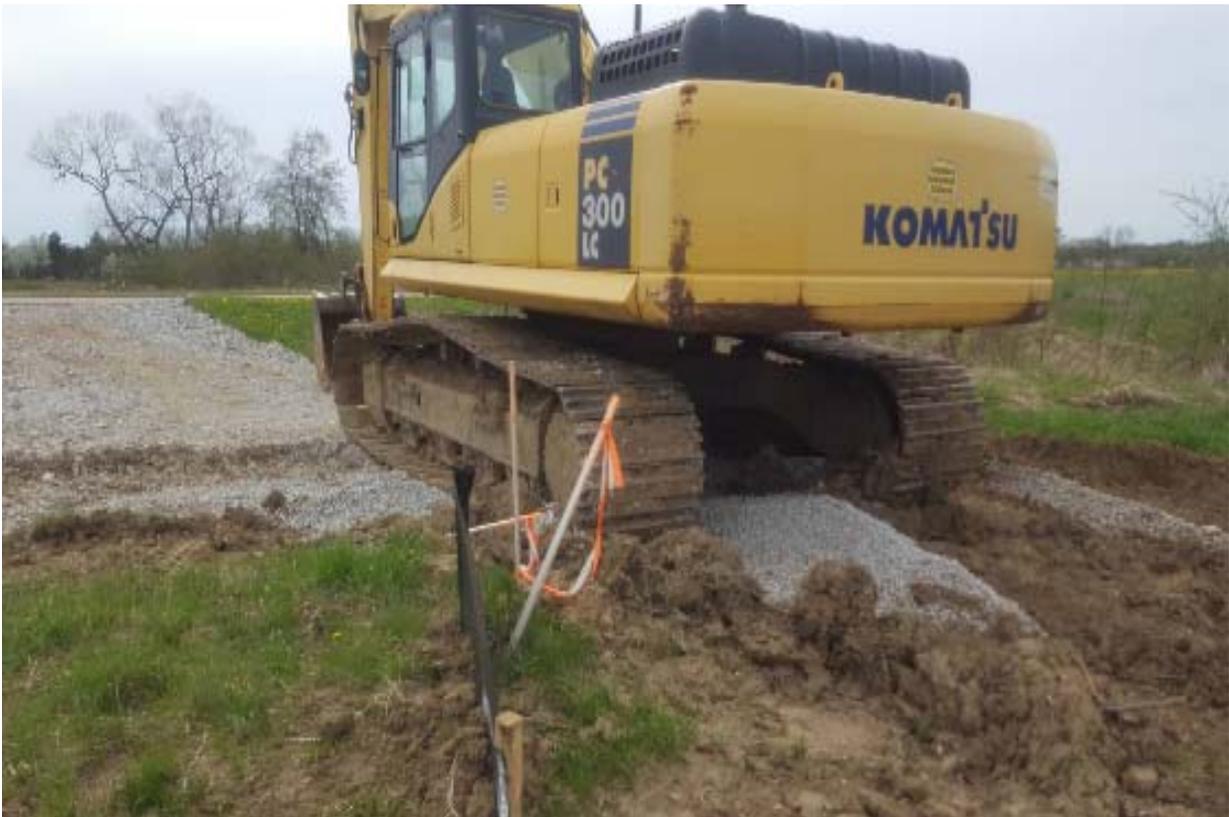
Acceptable Compliance Level, Spread 2, MP 70.5, View north at non-project related piece of equipment and associated ground disturbance.

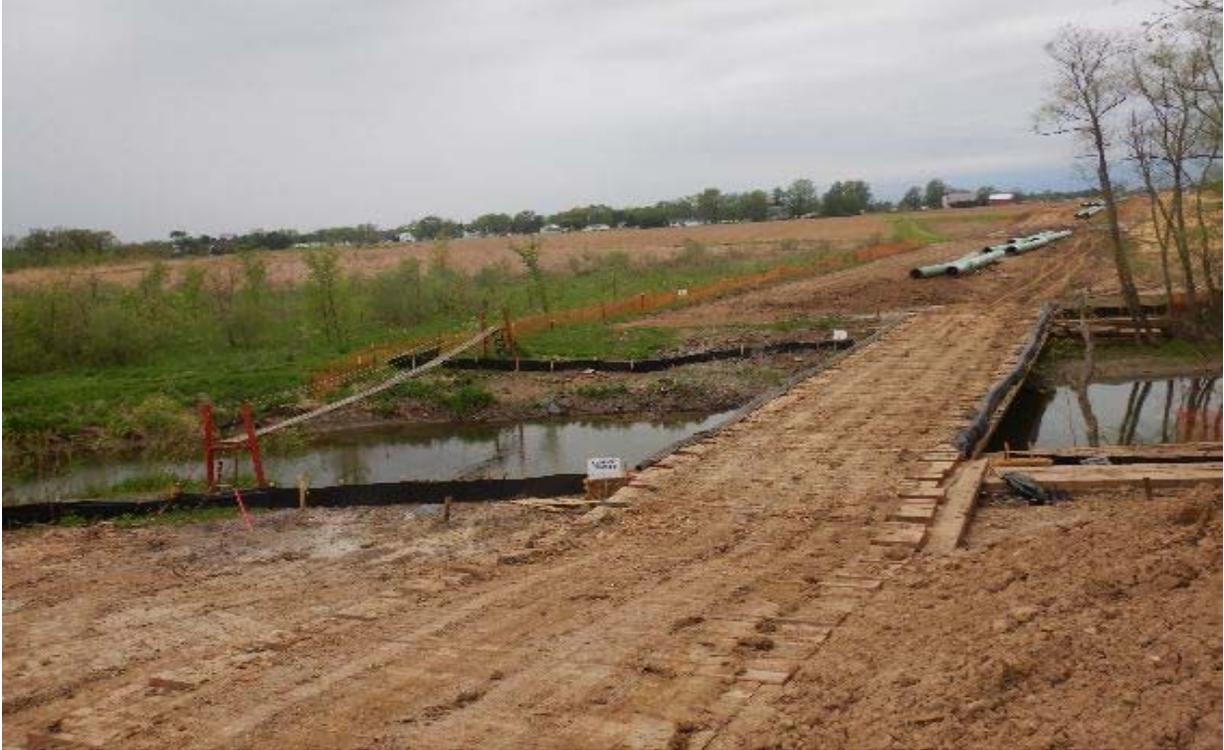
Acceptable Compliance Level, Spread 3, MP 154.4, View west of waterbody E14-43-S1 and wetland E14-43 crossing.

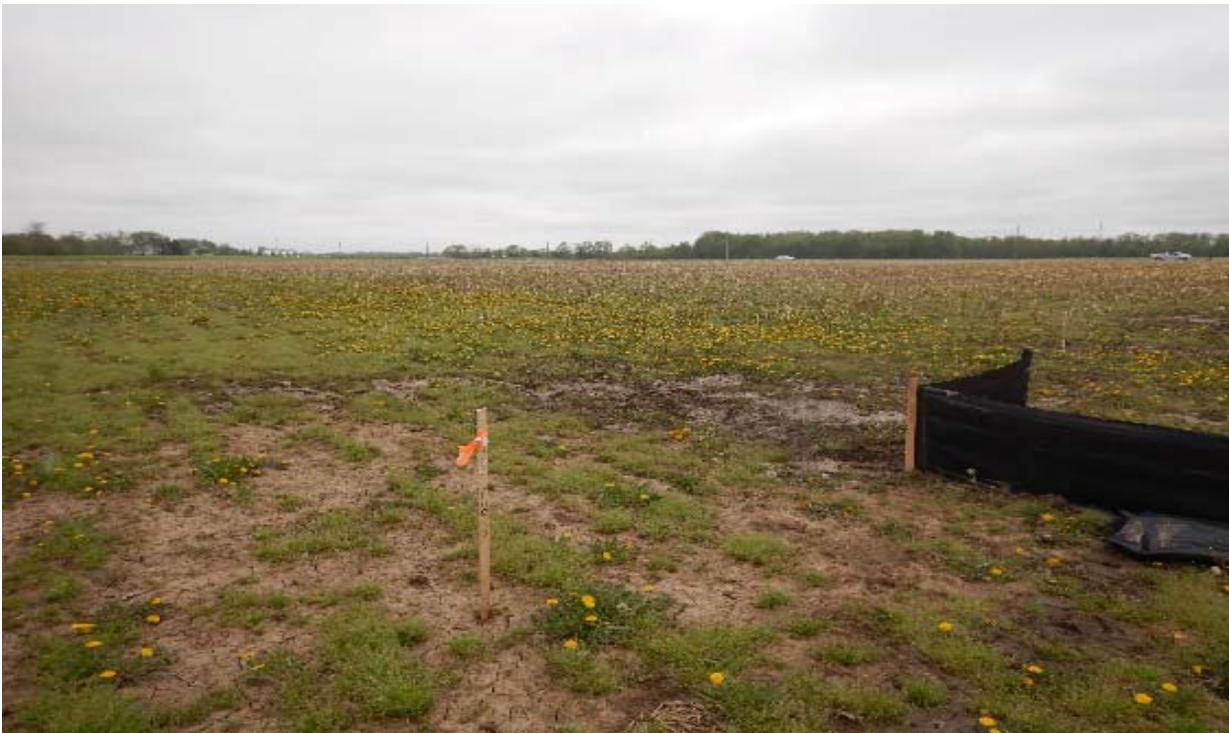
Acceptable Compliance Level, Spread 3, MP 163.6, View northeast of the extent of the drilling mud cleaned-up off-ROW at the Portage River HDD.

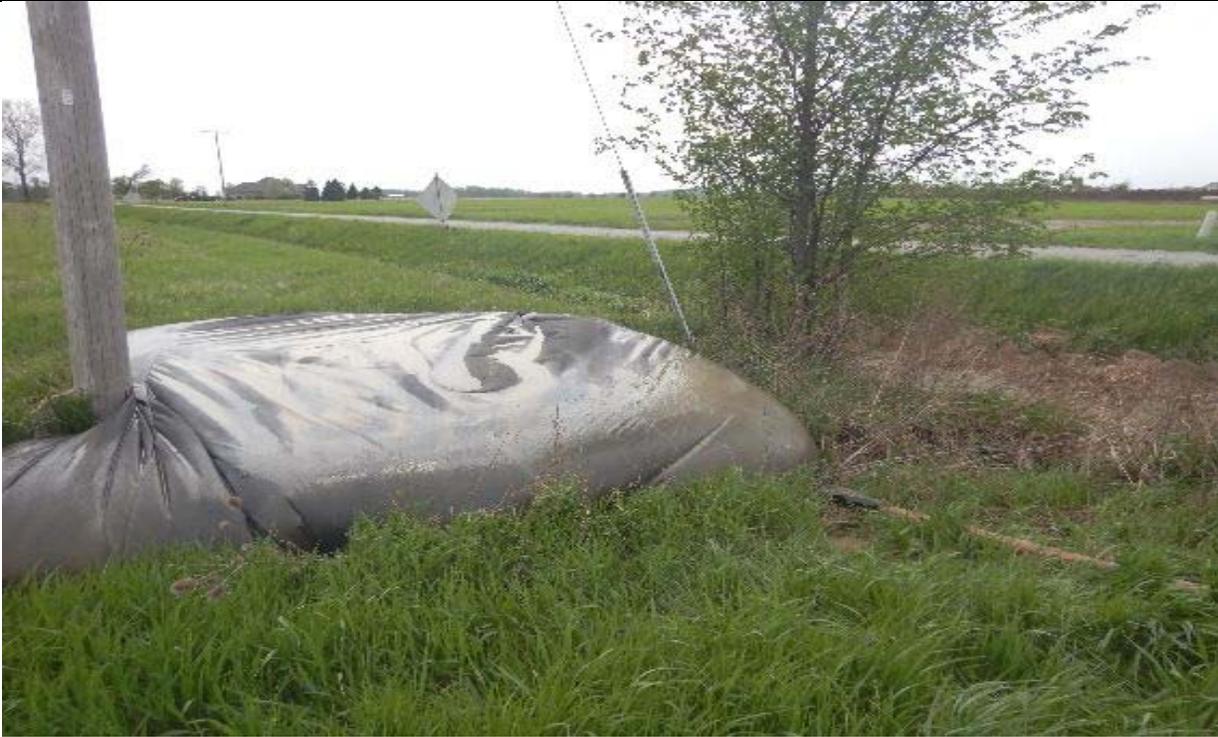
Acceptable Compliance Level, Spread 3, MP 171.8, View southwest a dewatering filter bag at the edge of the survey corridor, west of road bore CR-272 excavation.

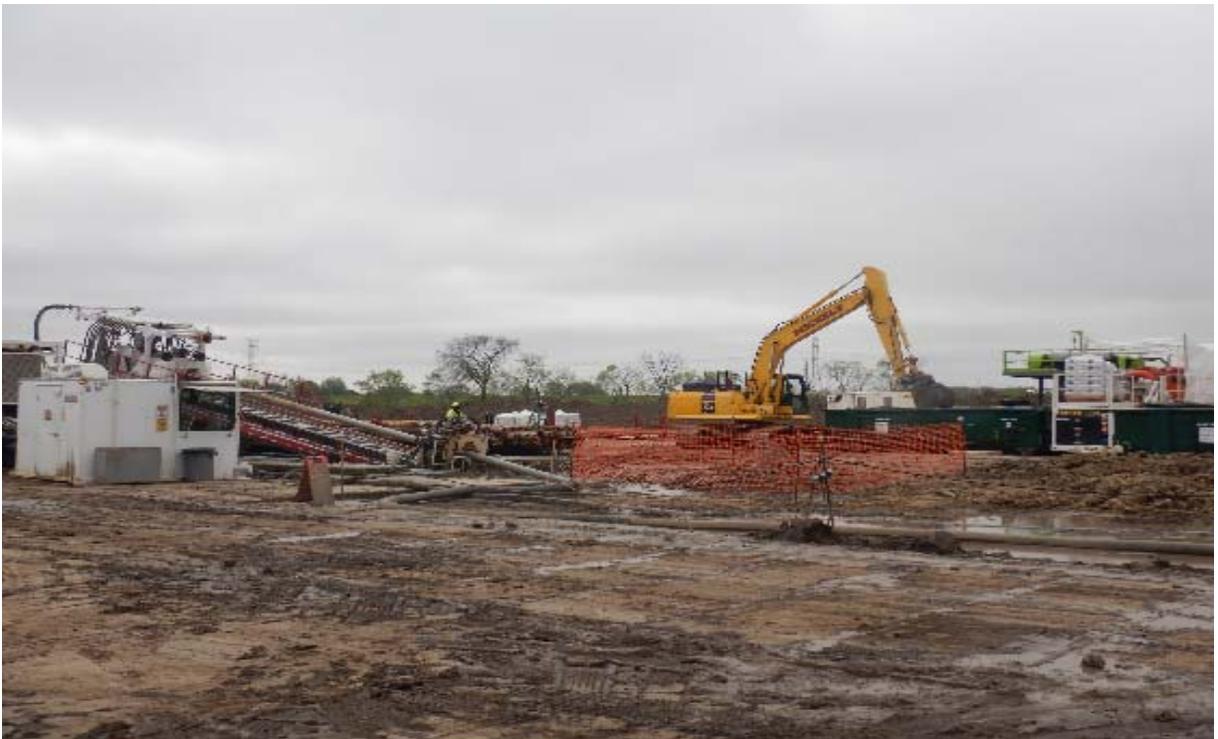
Acceptable Compliance Level, Spread 3, MP 182.0, View south of Maumee River HDD drilling rig.
