**FEDERAL ENERGY REGULATORY COMMISSION  
ENVIRONMENTAL COMPLIANCE MONITORING PROGRAM  
WEEKLY SUMMARY REPORT**

**NEXUS GAS TRANSMISSION PROJECT**

DOCKET NO.: CP16-22-000

FOR THE PERIOD: APRIL 30 THROUGH MAY 6, 2018

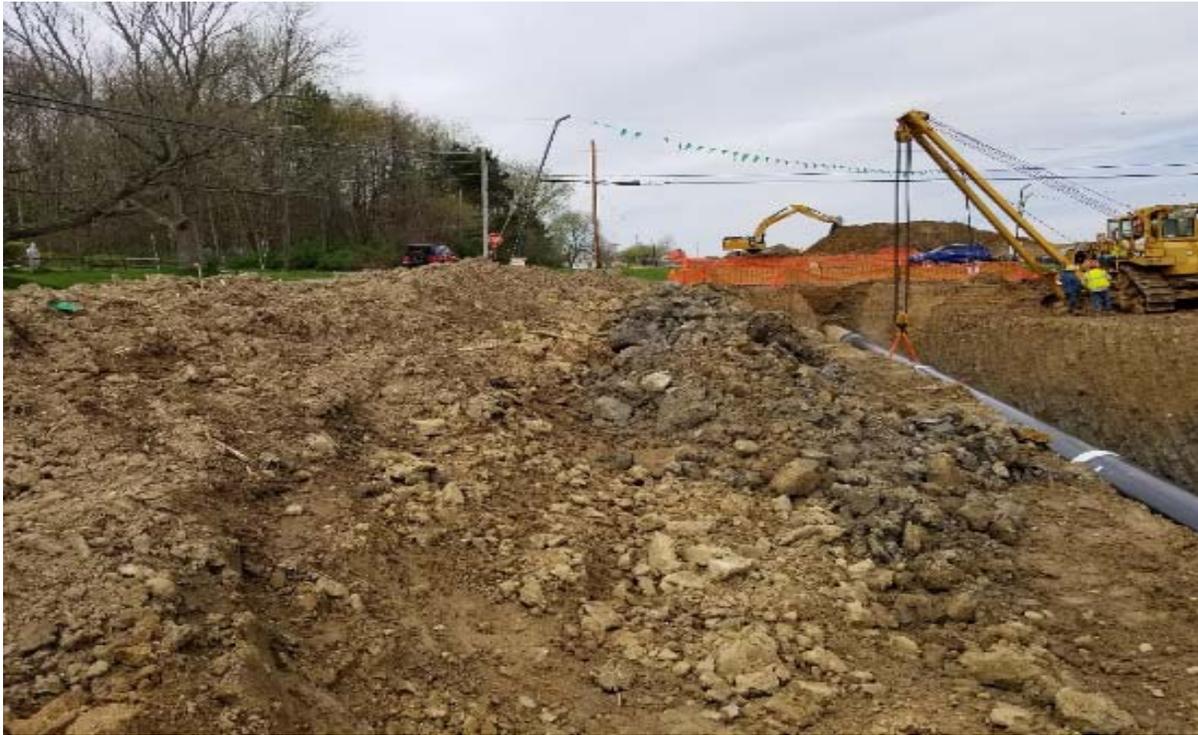
Communication Compliance Level, Spread 1, MP 14.0, View west of subsoil overlaying topsoil at road bore location yet to be resolved. The subsoil was pulled away later the same day.

5/5/18	1	14.0	No	<p>The CM observed subsoil, from the trench, partially overlaying the windrowed topsoil pile at the Highway 183 road bore site. The CM communicated the observation to the Lead EI. The Lead EI contacted the CM within an hour to inform the CM that the contractor was pulling the subsoil away from the stockpiled subsoil resolving the previously noted concern.</p>
5/5/18	2	70.5	Yes	<p>The CM observed a Komatsu 300 trackhoe parked outside the staked ROW boundaries of ATWS-4612, on North side of ROW at Technology Lane road crossing. The contractor was not onsite at the time. The CM informed the Lead EI who would find out if the equipment was Project-related the next working day. Prior to construction of the ROW in this area, a local non-project related contractor had been working near this road crossing. The CM would follow-up.</p>
5/5/18	3	186.3	Yes	<p>The CM was contacted by the Lead EI regarding a NEXUS documented problem area for incorrect grading in a fallow cultivated field. The Lead EI informed the CM that the incorrect side of the workspace (off-ROW) was graded connecting ATWS-966 to ATWS-220. The CM was informed by the Lead EI that the operator was outlining the workspaces (albeit incorrectly) and created an impact 6-8 inches deep by 50-feet-wide by 164-feet-long. Topsoil was not yet segregated; therefore the grading and ground disturbance was up to approximately 6 to 8 inches-in-depth. The CM informed the Lead EI that a level 2 variance approval would be required to repair the disturbed area. The CM would follow-up on the location.</p>

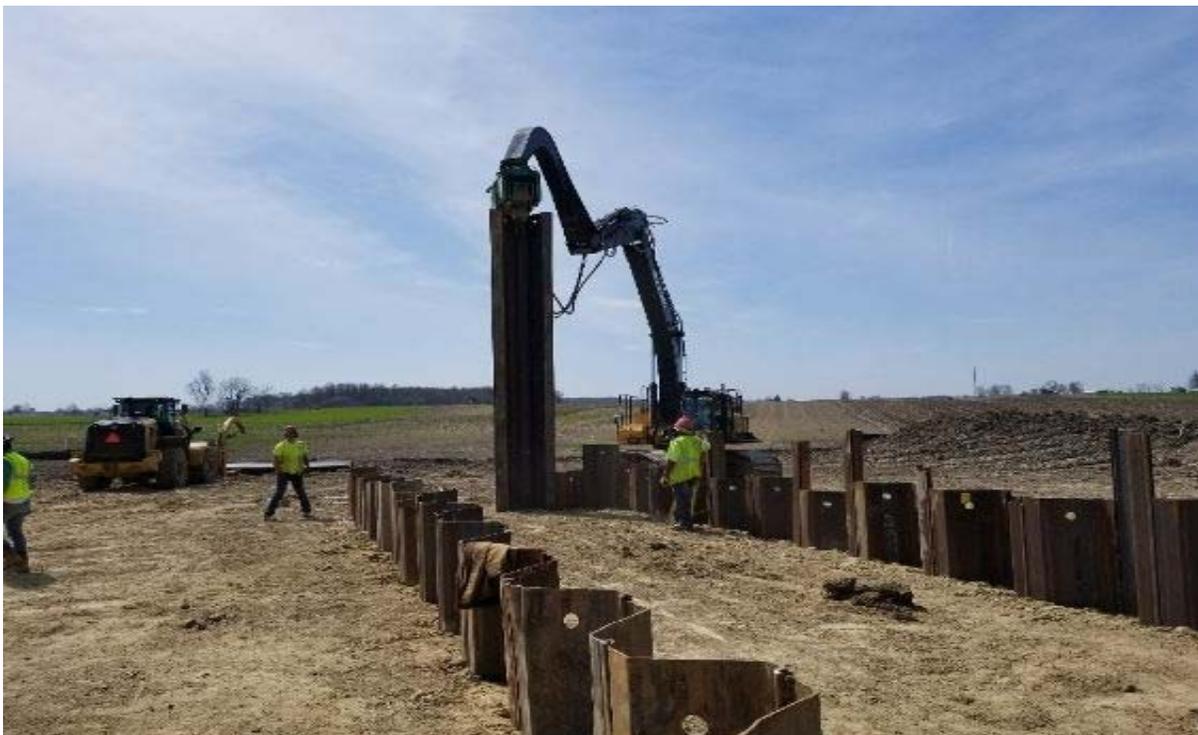
Acceptable Compliance Level, Spread 1, MP 20.4, View south of sheet piling installation at the bore site.

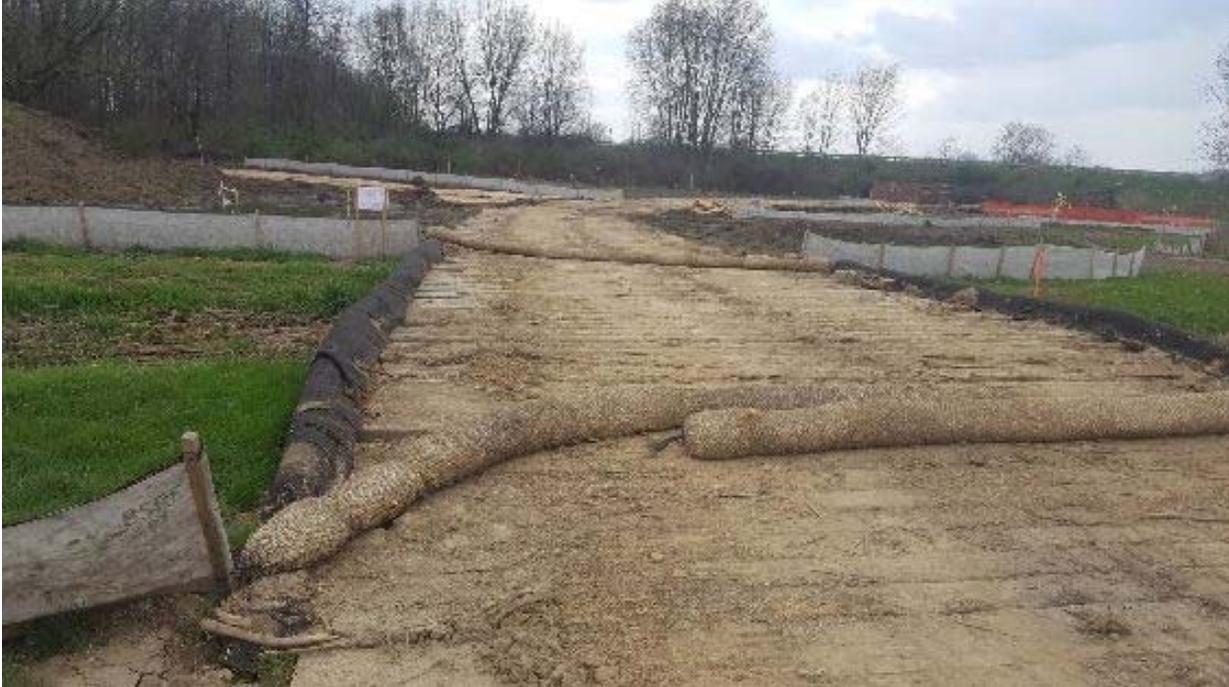
Acceptable Compliance Level, Spread 2, MP 57.3, View west of the timber mat bridge at stream B15-50-S2.

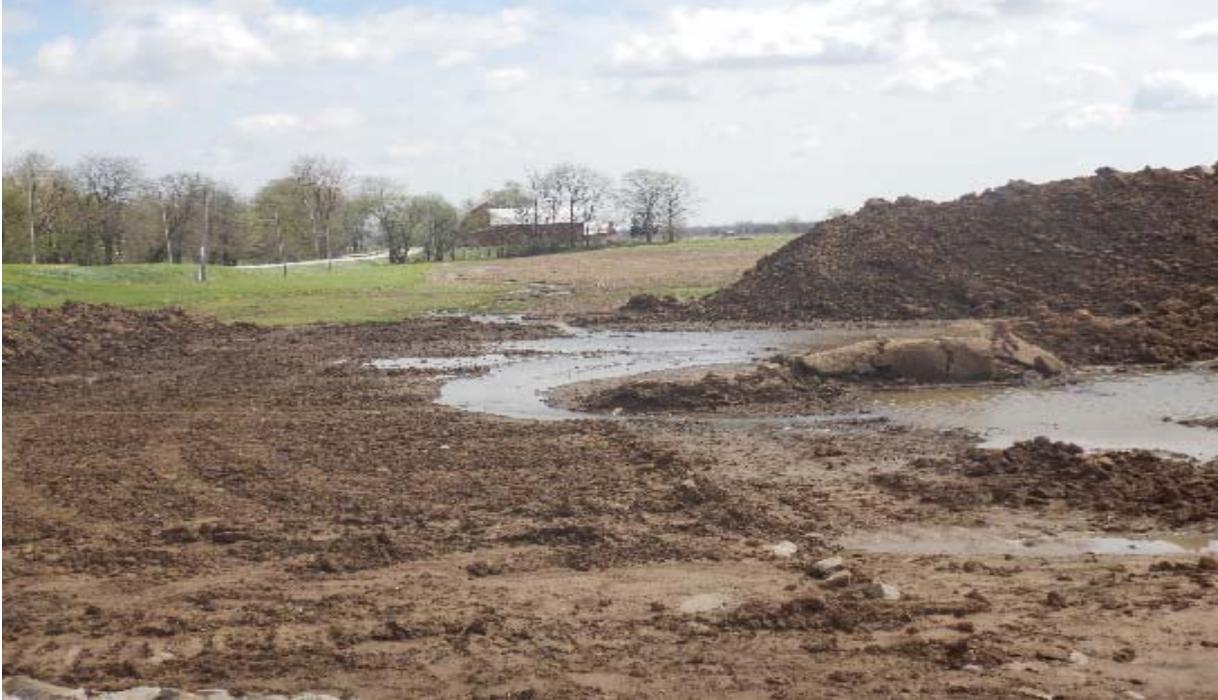
Communication Compliance Level, Spread 3, MP 163.4, View northeast at surface swale draining towards the Portage River. ECDs are recommended at edge of the ROW.

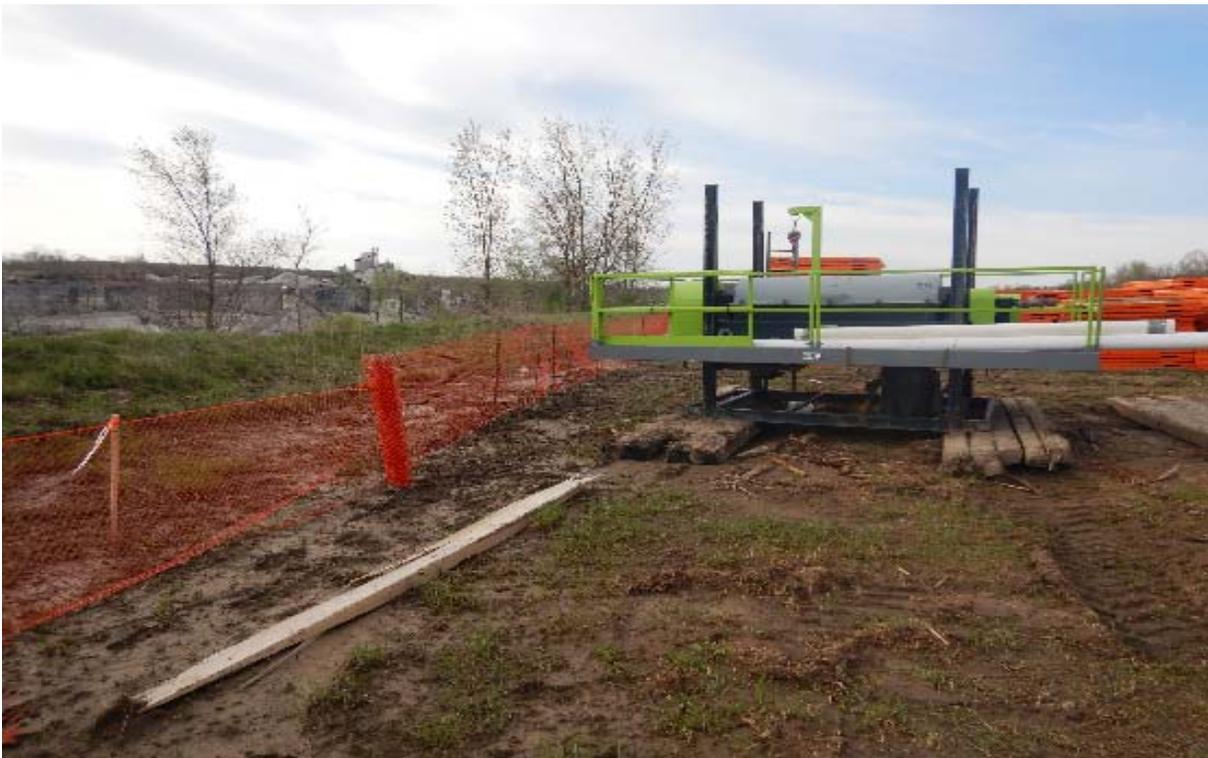
Acceptable Compliance Level, Spread 3, Wareyard 3-5, Follow-up to April 28 Communication Report, View southeast at safety fence repaired along wareyard perimeter.

<p>a water truck was sent to the area to help with the dust control. Buffalo Rd. is one of the few non-paved (gravel) roads on Spread 1. The CM noted a very rapid response to the noted concern.</p>
5/4/18	4	Wareyard 3-5	No	<p>On April 28 the CM observed a section of boundary safety fence to be down where the movement of equipment or materials (timber mats) had damaged the fence. Minor out-of-boundary ground disturbance (a few feet) beyond the wayard boundary was observed in the southeast corner of the wareyard. No sensitive environmental resources were impacted. The CM followed-up on May 4 and observed the safety fence still down and communicated the concern to the Lead EI. No new ground disturbance or off-ROW usage was observed. On May 5, the CM observed the safety fence to be replaced resolving the previously noted concern.</p>
5/4/18	3	163.4	Yes	<p>The CM observed a low area of cross drainage (surface swale) that acts as an intermittent drainage to the Portage River during heavy rain events. With this area graded to subsoil and not currently matted nor bridged, the CM noted concern of potential off-ROW sediment transport by erosion. The CM informed the Lead EI of the concern. The Lead EI stated the area would be followed-up on. The CM also was informed that the area received between 1.5 to 1.7 inches of rainfall the previous day. The CM would follow-up on the location.</p>

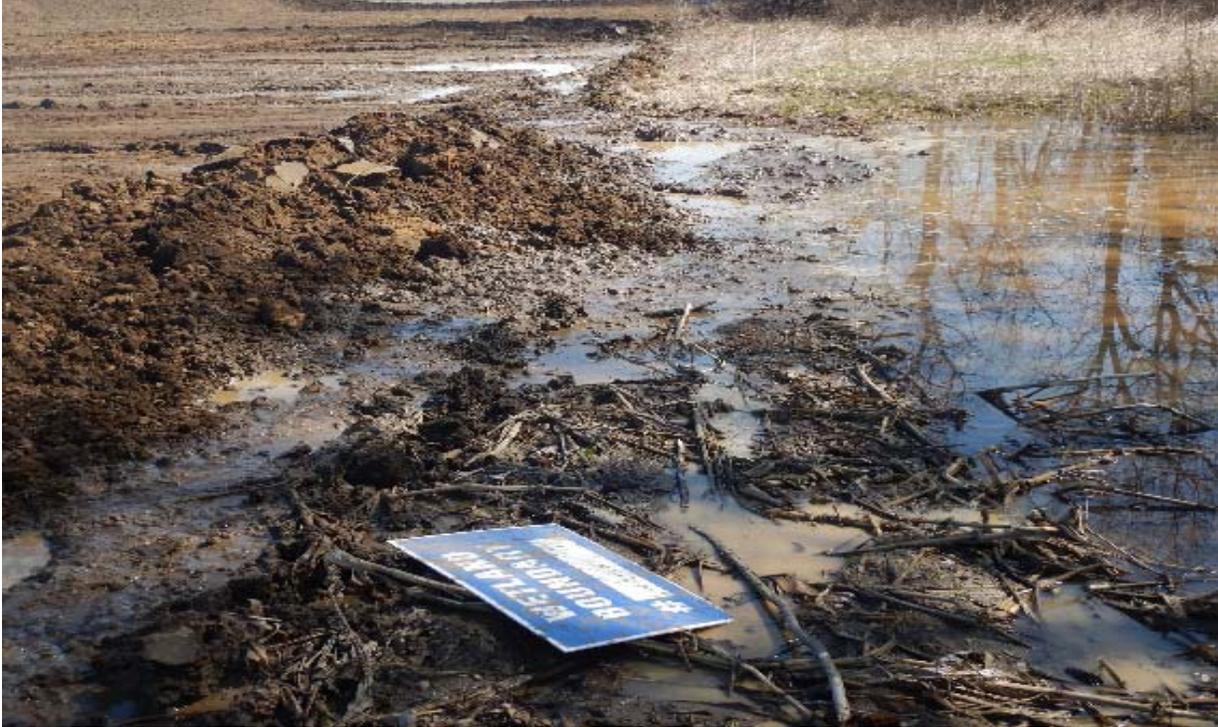
Communication Compliance Level, Spread 4, MP 239.1, April 30 NEXUS environmental inspection team problem area documented at this location. View east at no ECDs installed at wetland E14-158 and sediment migrating off-ROW

4/30/18	4	239.0	No	On April 28, the CM recommended installation of a sediment barrier ECD to prevent sediment discharge to wetland E14-158. On the morning of April 30, the CM followed-up at wetland E14-158 and did not observe any installed ECDs. Additionally, the CM observed a small amount sediment to be migrating off-ROW with the propensity for more sediment migration if ECDs were not installed. The EI stated the contractor environmental coordinator would be contacted to have ECDs installed. At noon, the CM discussed the concerns with the Lead EI who stated the issue would be documented by the environmental inspection team as a problem area. The CM followed-up later in the day and observed that silt fence was installed following the morning observation. Approximately one-wheel barrow load of off-ROW soil slurry was retrieved and returned to the graded ROW workspace. Wetland signage was also re-established. This observation resolves the previously noted concern.

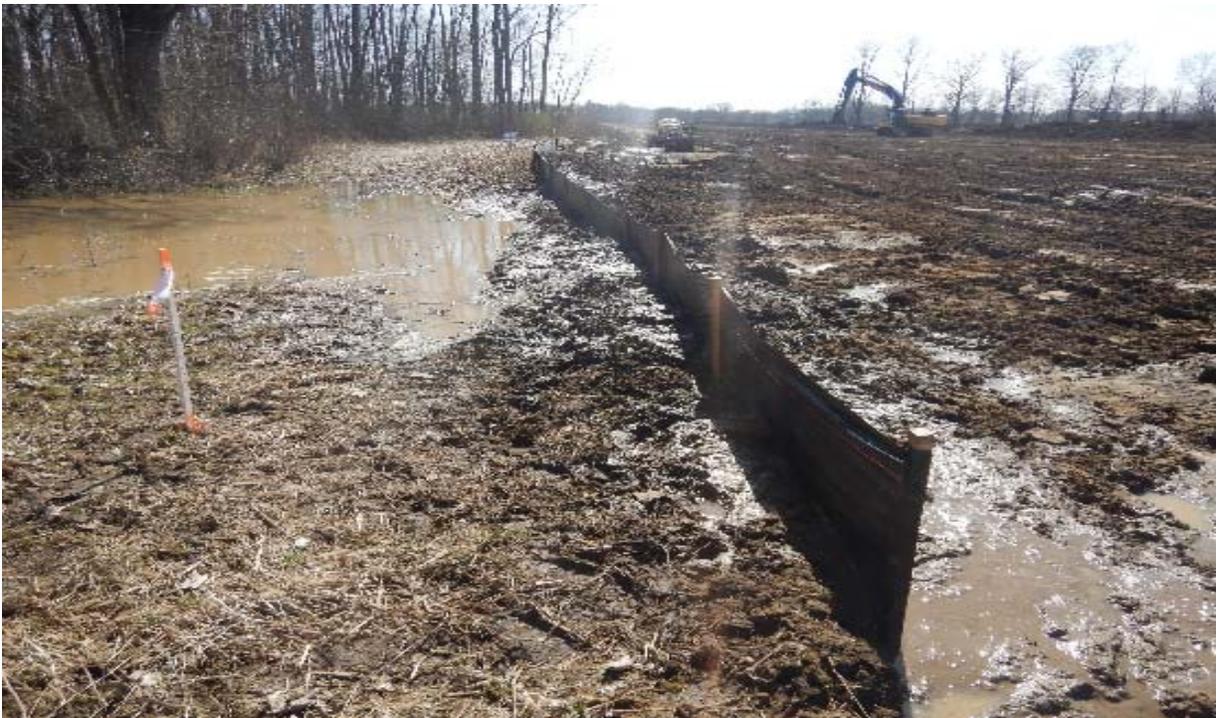
Acceptable Compliance Level, Spread 4, MP 239.1, Afternoon follow-up to morning of April 30 observation. View west at silt fence installed sediment barrier at edge of off-ROW wetland E14-158 after grading.
